# **Flood Investigation Report**

Storm Henk

2<sup>nd</sup> January 2024

**Glooston**

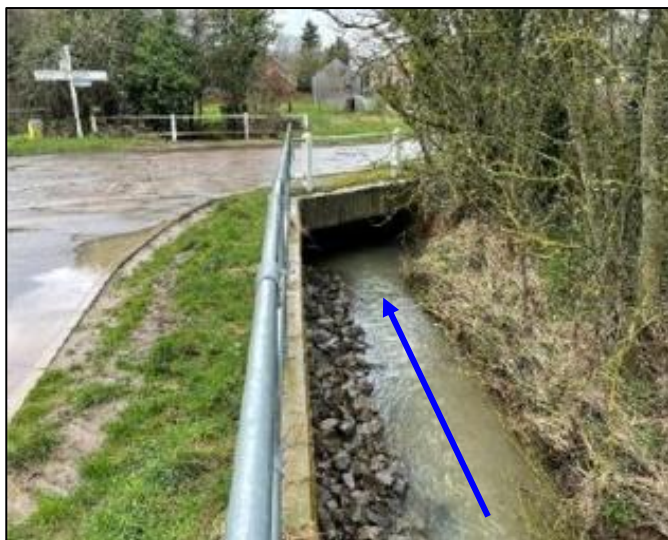
**Photograph 7-1: Glooston Arm at the Harbrough Road bridge culvert inlet looking downstream from Cranoe Road<sup>3</sup>**

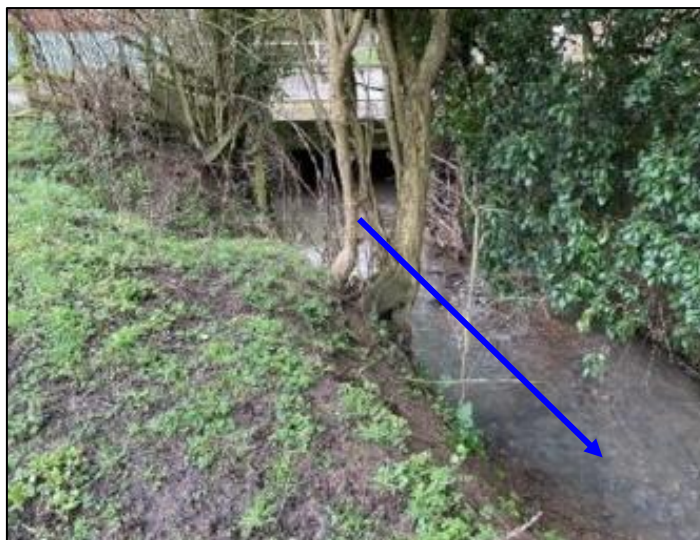
**Photograph 7-2: Glooston Arm at the Harbrough Road bridge culvert outlet looking upstream from Main Street<sup>3</sup>**

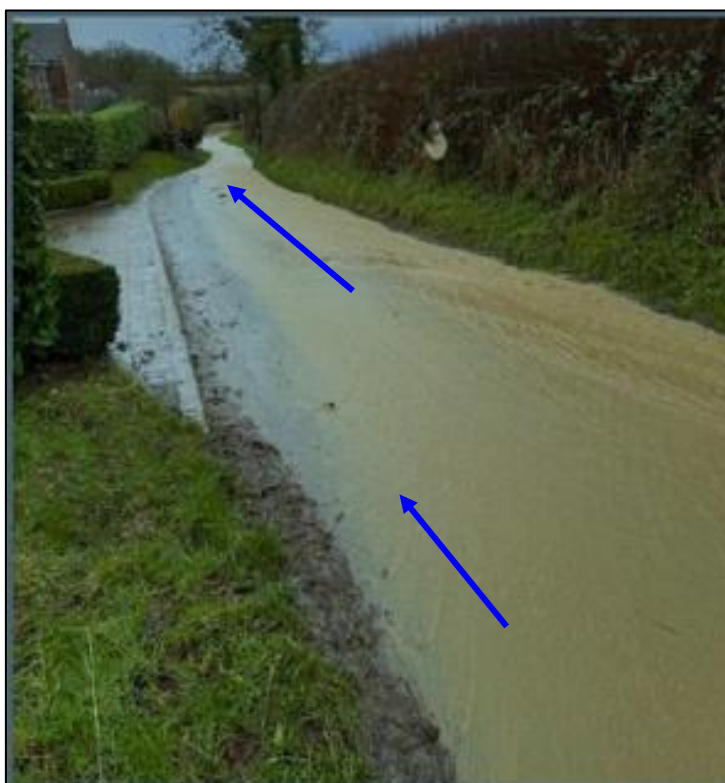
Surface water flowed off the fields in the surrounding agricultural catchment which exceeded the capacity of land drain ditches and tipped onto Goadby Road, Cranoe Road and Harborough Road. The capacity of drainage ditches running alongside these roads was also exceeded by the volumes of surface water runoff. These roads therefore acted as conduits for the flood water which headed towards the Harborough Road bridge as shown in Photograph 7-3. Properties along Goadby Road reported internal flood depths of approximately 350mm.

**Photograph 7-3: Surface water flowing down Goadby Road towards Glooston village centre**

| ACTION | ACTION DETAIL | LEAD RMA | CURRENT STATUS |
|---|---|---|---|
| <b>Highway Drainage Improvements</b> | Install more grips on Goadby Road, Cranoe Road and Harborough Road to improve the efficiency of water removal from the highway during more frequent rainfall events. | LCC LHA | Complete – 23 <sup>rd</sup> September 2024 under job reference 666254: <ul style="list-style-type: none"> <li>• Goadby Road – 4 grips north of 20<sup>th</sup> Godby Road</li> <li>• Cranoe Road – grips opposite Brookside Cottages and 3 more along approach into village.</li> </ul> Main Street – 2 grips opposite Home Farm and concrete grip by finger post. |

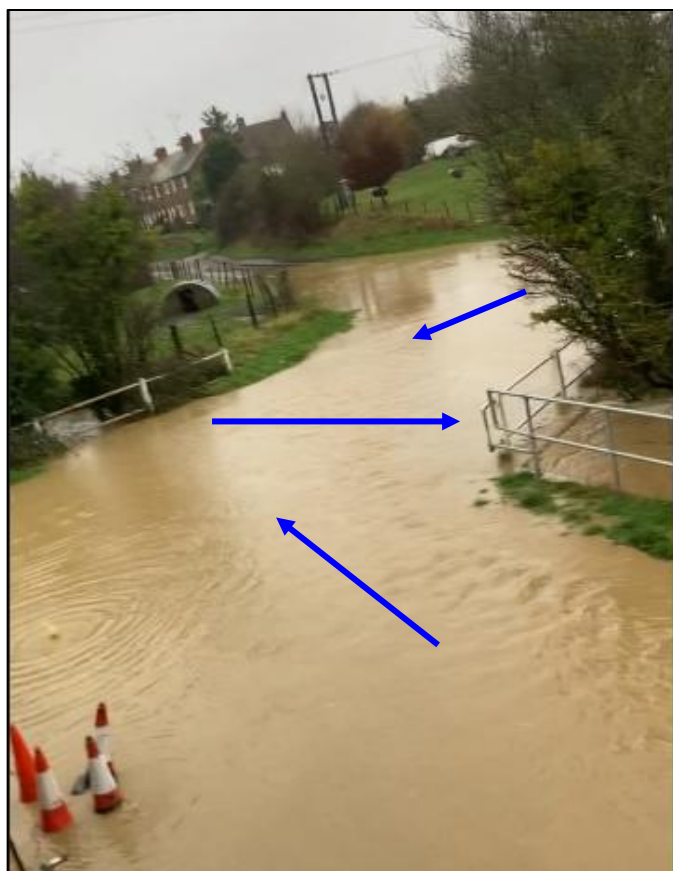
Out of bank flow, which had exceeded the capacity of the Glooston Arm channel and overtopped the bank thresholds, also progressed westwards down Cranoe Road towards the same location as shown on Photograph 7-4 and Photograph 7-5.

**Photograph 7-4: View from Cranoe Road of Harborough Road bridge deck flooded looking downstream towards Main Street**

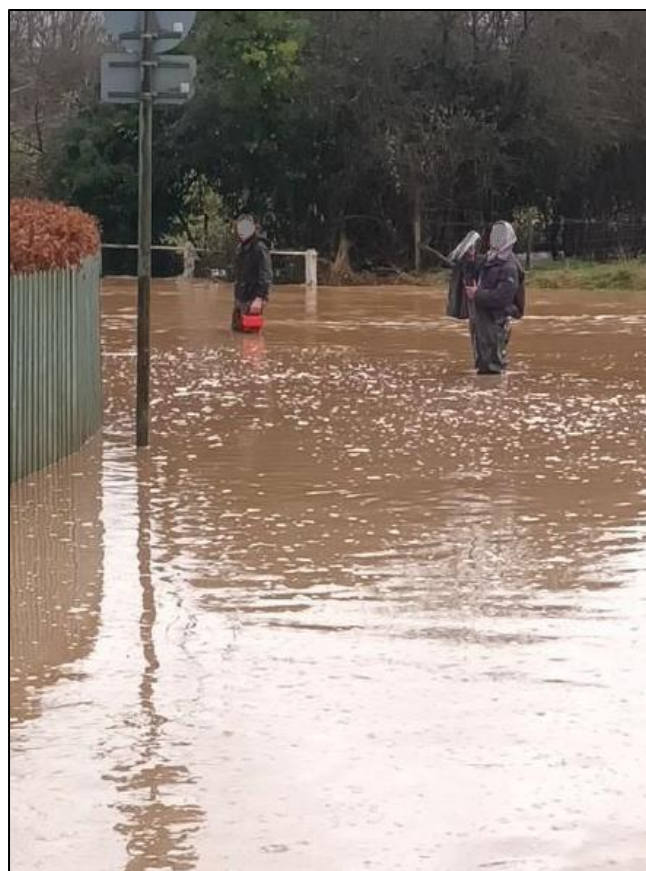
**Photograph 7-5: Flooding at junction of Main Street and Goadby Road<sup>3</sup>**

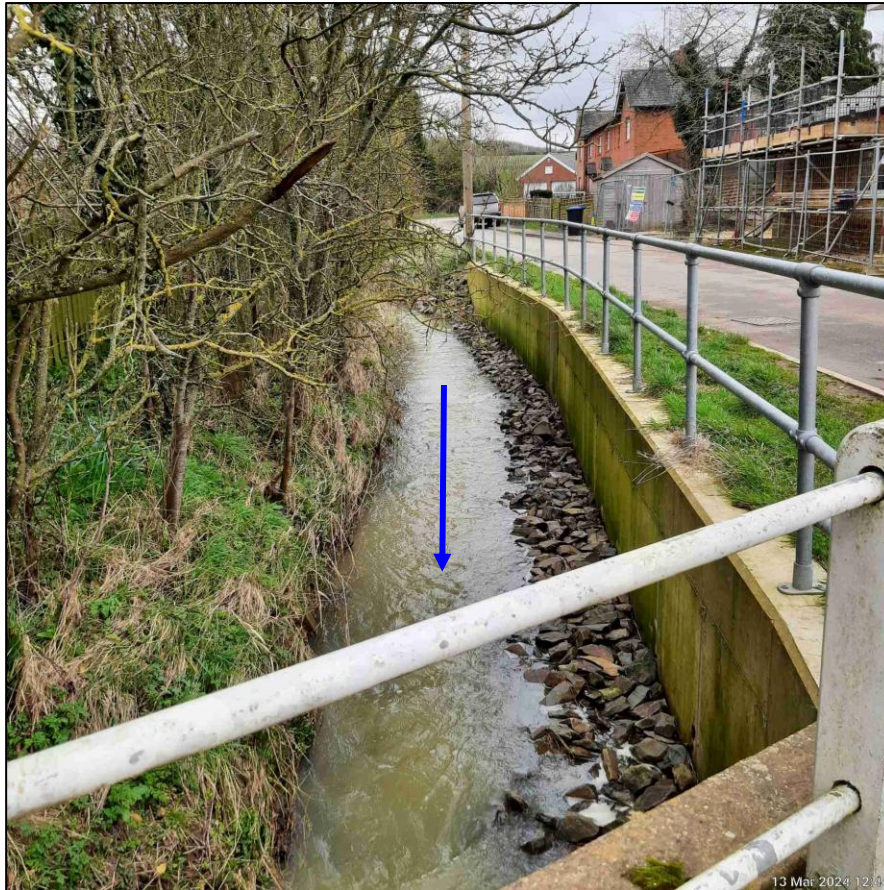
Historically, the bridge culvert was installed to replace an arched-bridge, and the south river bank (on the northern side of Cranoe Road) on approach to the bridge culvert was reinforced. A wall was installed with rip-rap (large rocks) (Photograph 7-6) to prevent erosion of the earth embankment that was exhibiting deterioration.

**Photograph 7-6: Bank reinforcement upstream of Harbrough Road Bridge looking eastwards towards Cranoe Road**

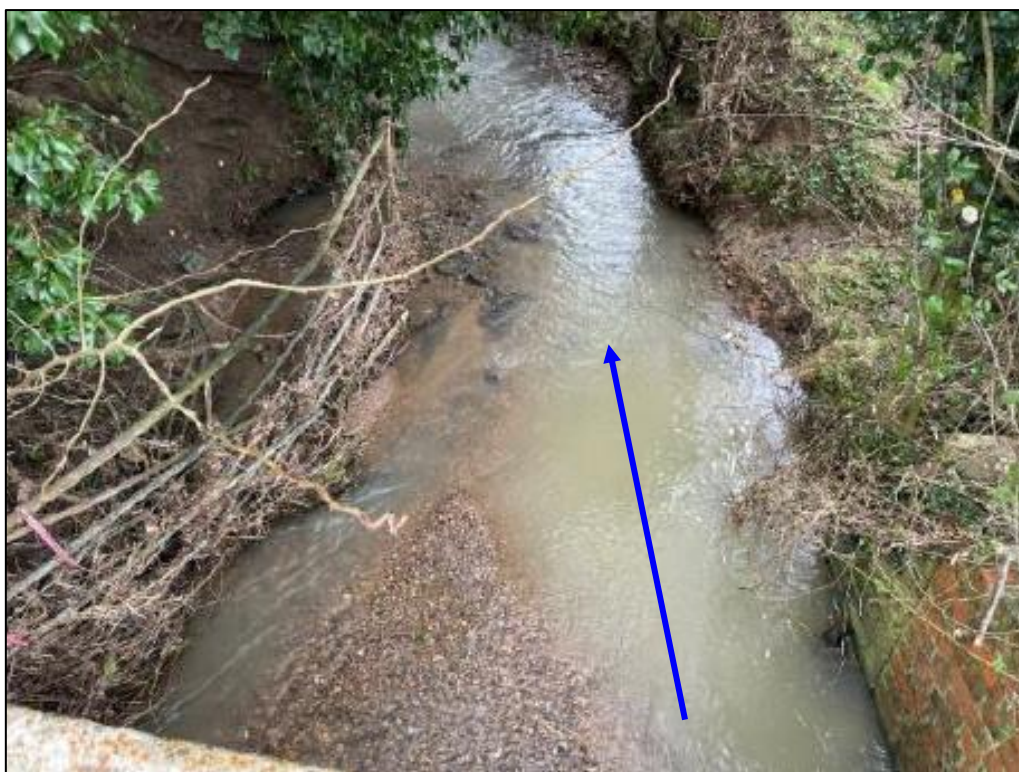
The Harborough Road bridge culvert itself, conveying the Glooston Arm, was observed during the flood event to be flowing at full capacity. The downstream extent of the bridge culvert was also observed to be significantly silted after the flood event (Photograph 7-7). A proportion of this may have been mobilised within the catchment, transported into the watercourse channel and deposited during the flood event as flow speed reduced. Leicestershire County Council (LCC), the Local Highways Authority (LHA), were not aware of any obstructions prior to the flood event.

**Photograph 7-7: Silt deposition within the Glooston Arm on outlet of the Harbrough Road Bridge culvert looking downstream following the flood event<sup>3</sup>**

| ACTION | ACTION DETAIL | LEAD RMA | CURRENT STATUS |
|---|---|---|---|
| <b>Riparian landowner engagement</b> | Liaise with the riparian landowner of the channel immediately downstream of the culvert which runs under Harborough Road. Ensure any obstructions are removed to allow the culvert to convey its full design capacity. | LCC LLFA | Complete |

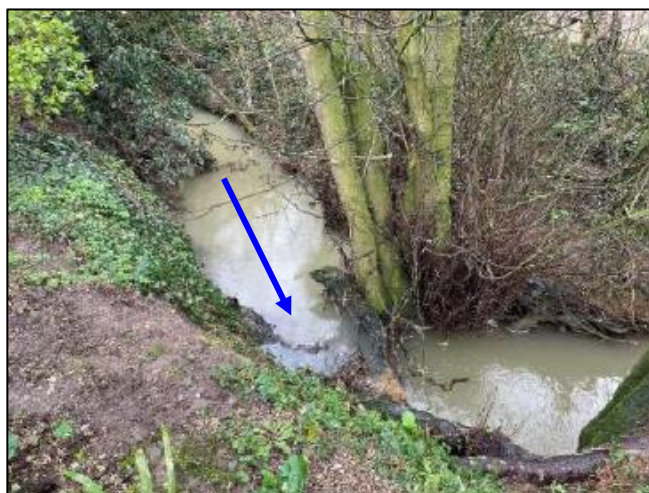
After the flood event, a site inspection in February 2024 identified minor vegetation and litter debris obstructions in the Glooston Arm channel exacerbated by tree roots on the bank sides (Photograph 7-8) and boundary fences that crossed the channel (Photograph 7-9). These likely reduced the channel conveyance capacity, locally raised water levels and re-routed flows in the immediate vicinity before they bypassed the obstruction and returned to the channel. These restrictions were not considered to be the primary cause of the flooding as the volume of runoff significantly exceeded the capacity of the drainage system. It is likely however that they exacerbated flooding close to their immediate location.

**Photograph 7-8: Vegetation debris within Glooston Arm channel<sup>3</sup>**

| ACTION | ACTION DETAIL | LEAD RMA | CURRENT STATUS |
|---|---|---|---|
| <b>Ordinary Watercourse Conveyance Improvement Works</b> | Ongoing engagement with riparian landowners to ensure proactive future maintenance to remove obstructions that may impede flows within the channel. | LCC LLFA | Complete |

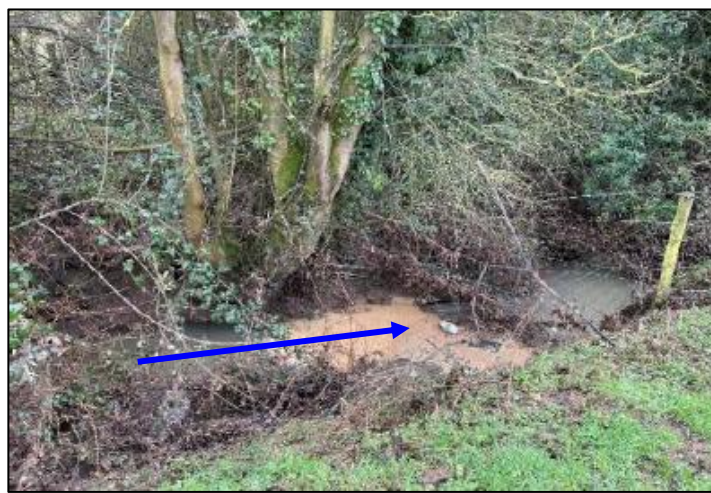
**Photograph 7-9: Vegetation debris within Glooston Arm channel<sup>3</sup>**

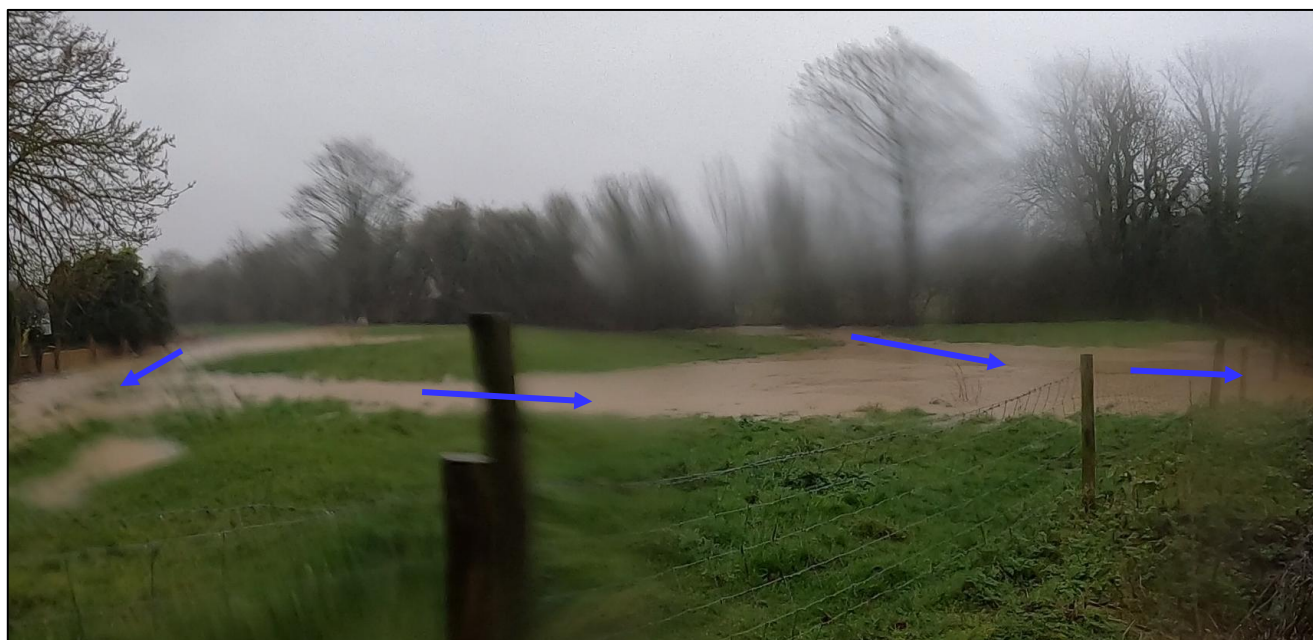
Just downstream of the Harborough Road bridge culvert, video footage taken during the Storm Henk event shows the flows from the Glooston Arm coming out of bank and flowing across a paddock, as depicted in Photograph 7-10. The fluvial flows appeared to be following a historic brook channel (paleochannel). The brook in this location appears to have been straightened when compared with other meandering sections nearby, and the historic channel is visible on LiDAR.

**Photograph 7-10: Flooding of the Glooston Arm as overland flow across the paddock viewed from Bluebell Lane**

| ACTION | ACTION DETAIL | LEAD RMA | CURRENT STATUS |
|---|---|---|---|
| <b>Flood Bund</b> | Support with community-led proposals for a bund within the paddock area. | LCC LLFA | Ongoing |
