# **Flood Investigation Report**

Storm Henk

2<sup>nd</sup> January 2024

**Fleckney**

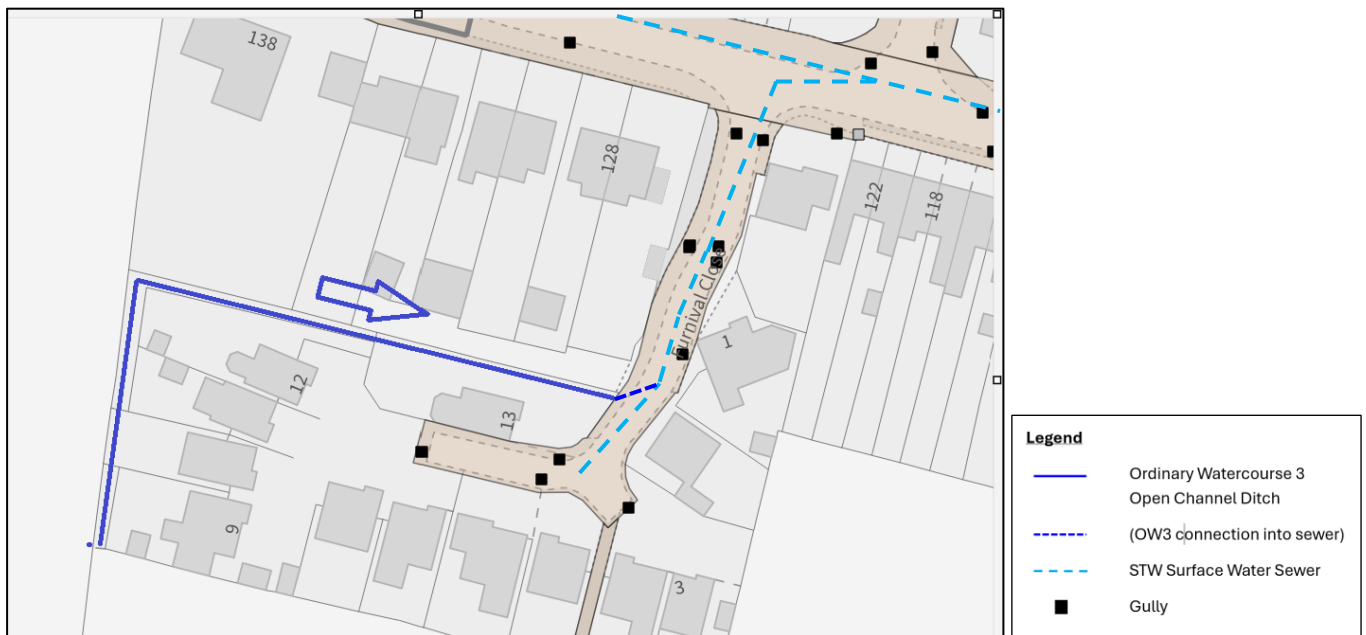
**Figure 15-3: Ordinary Watercourse 3 at Furnival Close connecting into STW Surface Water Sewer**

Anecdotal reports were received of significant volumes of surface water running over fields towards properties to the rear of Furnival Close (Flood Area D). The surface water was described to enter Ordinary Watercourse 3, then proceed towards the culvert inlet to the STW public sewer system on Furnival Close, as illustrated in Figure 15-3.

Water was described to overwhelm the watercourse and overtop onto the 'jitty' (a privately owned access track to garages for properties on Kilby Road, adjacent to Furnival Close). Flooding continued towards Furnival Close where it pooled and flowed to the natural low point around a residential property. This property was surrounded and flooded internally from both the front and rear as the garden is walled and so it is likely that this stopped the water from flowing on further and increased the depth of flooding.

Anecdotal reports stated that in Furnival Close, highway drainage was originally taking water away but then they backed up and water rose (surcharged) out of gullies during the event. The highway drainage system connects onto the STW public sewer system at this location. Typically, road drainage networks are designed to accommodate limited rainfall event on the contributing area of highway itself, but not for any additional volumes of overland flow originating from land adjacent to the highways, or overtopping onto them from watercourses, as occurred here.

Following Storm Henk, STW conducted a camera survey of the public sewer network at this location and found it to be clogged with debris, this has since been jetted and cleared. It is highly likely that some of this material was mobilised and washed down during the flood event. No reports of any blockages were made to LCC or STW prior to Storm Henk. If the STW public sewer system became obstructed, then this could have impacted the gullies being able to effectively drain the highway and potential surcharging. A collapsed drain was also identified at the junction of Furnival Close and Kilby Road, this has since been rectified by STW but at the time could have also contributed to the flooding of the sewer network initially.

| ACTION | ACTION DETAIL | LEAD RMA | CURRENT STATUS |
|---|---|---|---|
| <b>Public Sewer Network Maintenance and Investigations</b> | Conduct maintenance works and camera survey to the public sewer network at Furnival Close. | STW | Complete |

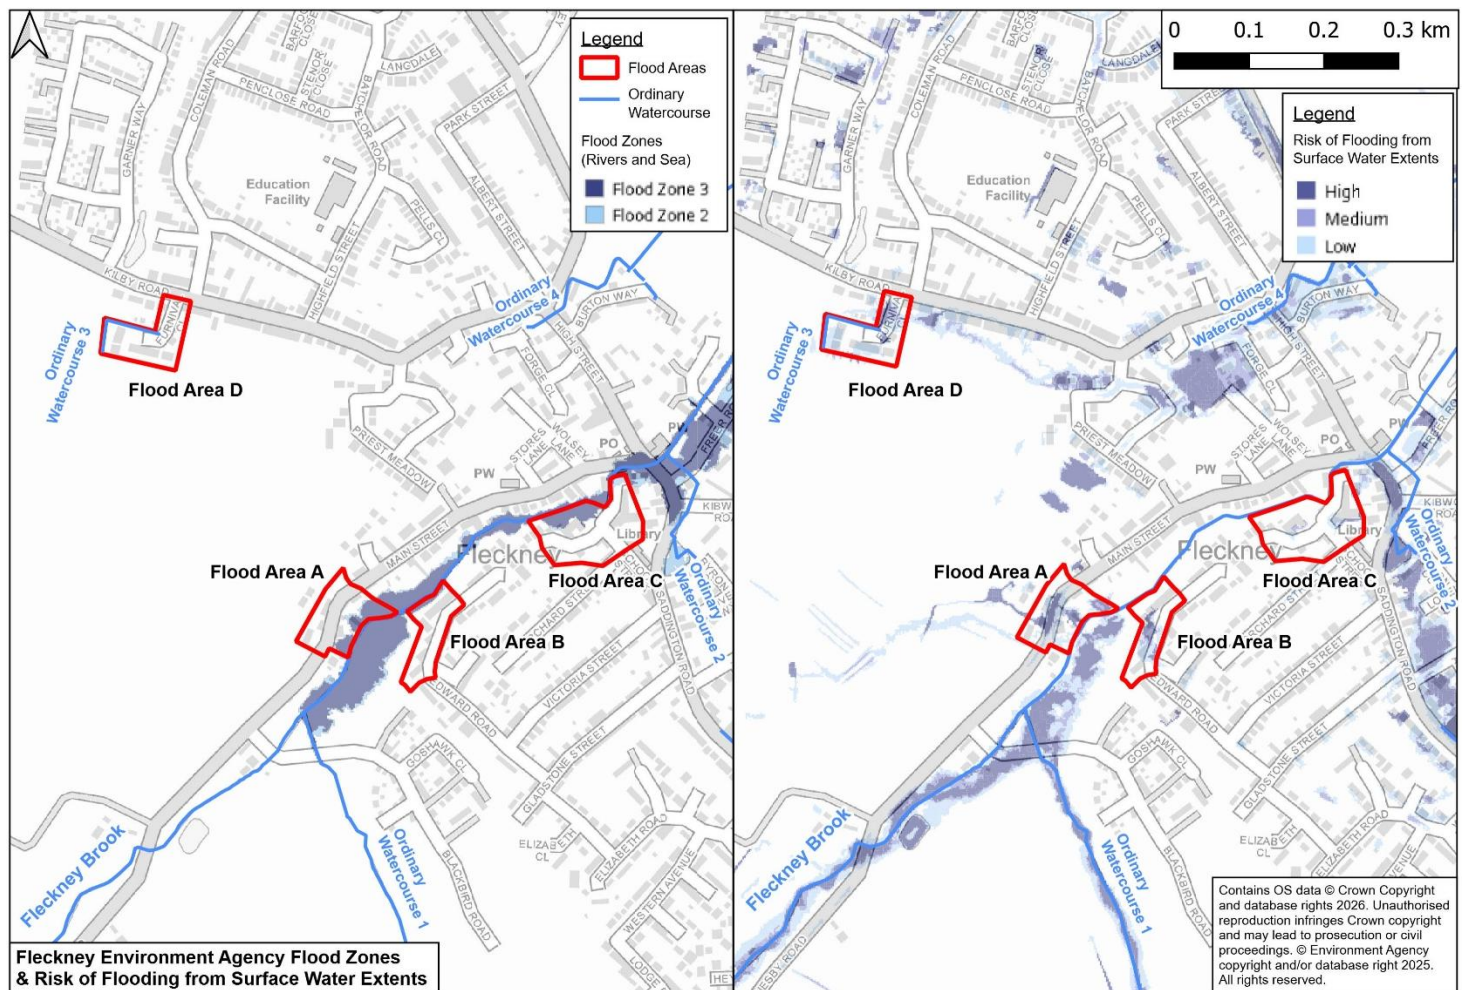
**Figure 15-4: Fleckney EA Flood Map for Planning Flood Zones<sup>3</sup> and Risk of Flooding from Surface Water Extents<sup>4</sup> in Flood Areas (INSET 14)**

Flood Area A, B and C are illustrated in Figure 15-4 as also being at low to high risk from surface water flooding. Surface water was reported to have originated off land to the north of Arnesby Road (some of which is ridge and furrow which would have exacerbated channelling of surface water towards the road), entered onto Main Street and headed towards Fleckney Brook (close to the Blackbird Road attenuation pond). One additional property on Main Street is believed to have been flooded internally from the rear due to runoff from the fields.

Regardless of any obstructions, the sheer volume of rainfall that fell during the event would have overwhelmed the entire drainage network including the public sewer network. The flooding at Furnival Close closely matches with the areas identified by the EA's surface water flood map (Figure 15-4) with properties and the highway in this area being identified as being at low, medium and high risk of surface water flooding.

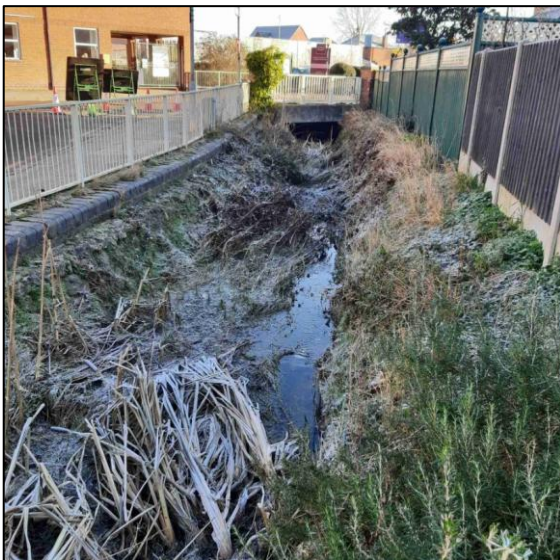
Anecdotal reports were made of overgrown vegetation within Fleckney Brook adjacent to the Baptist Church and also just downstream on the Howlett Road development site. No evidence has been found by Leicestershire County Council (LCC), the Lead Local Flood Authority (LLFA), to indicate that overgrown vegetation increased the number of properties that internally flooded, although it is possible it may have increased the extent of flooding locally.

**Photograph 15-1: Fleckney Brook alongside Main Street looking downstream (near the junction with High Street) before channel maintenance**

Recognising the heightened concerns of the community following the flood event (despite the section of watercourse being privately owned) as a gesture of goodwill, the Local Highways Authority (LHA) conducted some channel maintenance at this location on 25<sup>th</sup> October 2024 (see Photograph 15-1 before and Photograph 15-2 after maintenance was completed). This work was completed with the key aim of improving conveyance within the watercourse to allow the highway drainage to outfall more efficiently. Following Storm Henk, Fleckney Parish Council also undertook clearance works on Fleckney Brook to help improve conveyance and this includes sections alongside the development compound at Howlett Road.

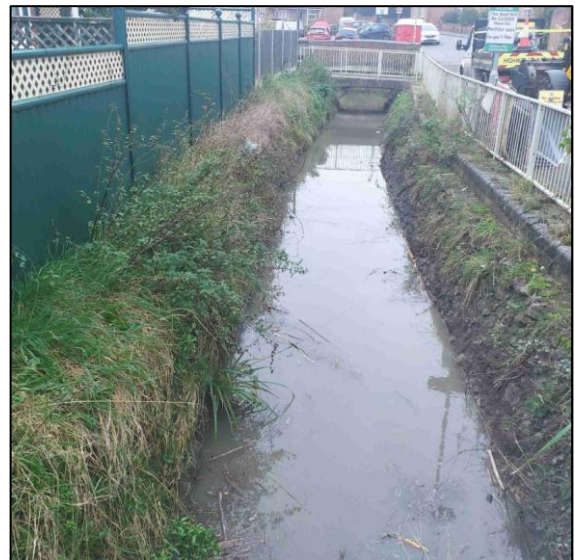
**Photograph 15-2: Fleckney Brook alongside Main Street looking upstream (near the junction with High Street) after channel maintenance**
