**Lutterworth East**

**Feasibility Study: Misterton Marshes SSSI.  
Core Strategy Representations.**

September 2016

**FPCR Environment and Design Ltd**

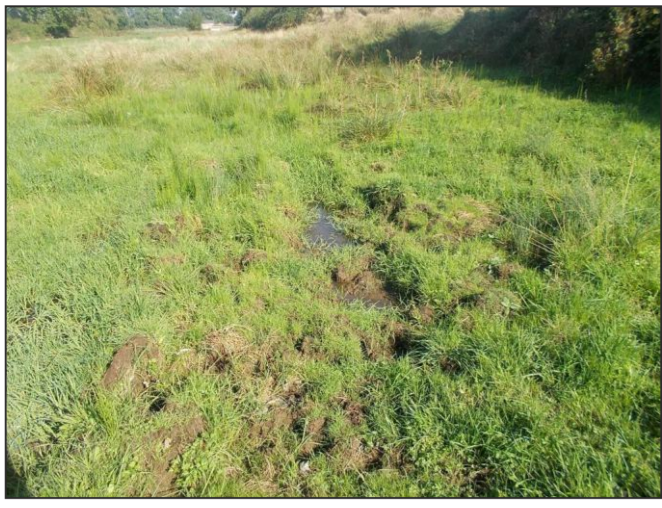
Inset 1 - Buggy ground observed to the north of the SSSI near point B1 and standing water indicative of a groundwater source.

Item	Subject
	<p>Areas of waterlogged ground with high standing water were observed approximately 250m to the north west of the SSSI. The location of the boggy areas and photographs are presented in Inset 1 and 2 on <b>Figure TN002/1</b>. The presence of waterlogged ground at the end of summer suggests that a probable groundwater source is present in the area and this may be providing baseflow to Stream B at point B1 upgradient of the SSSI.</p> <p>Evidence of a second probable groundwater source was also observed along Stream C approximately 300m to the west of the SSSI and this is presented in Insets 7 and 8 on <b>Figure TN002/1</b>. The stream flow within Stream C at point C2 was observed being significantly larger in volume than the section immediately upgradient at point C1. The sudden increase in stream flow over a short distance suggests a probable ingress of groundwater into Stream C. Two historical springs are recorded adjacent to point C2, however at the time of the visit the locations could not be investigated owing to the dense vegetation along the stream course and a tall crop of maize in the fields.</p> <p>A number of valley features were observed immediately to the east and south of the SSSI and their locations are presented in <b>Figure TN002/1</b>. While no groundwater sources were identified at these locations at the time of the visit, groundwater discharge may be occurring during periods of high groundwater level.</p>

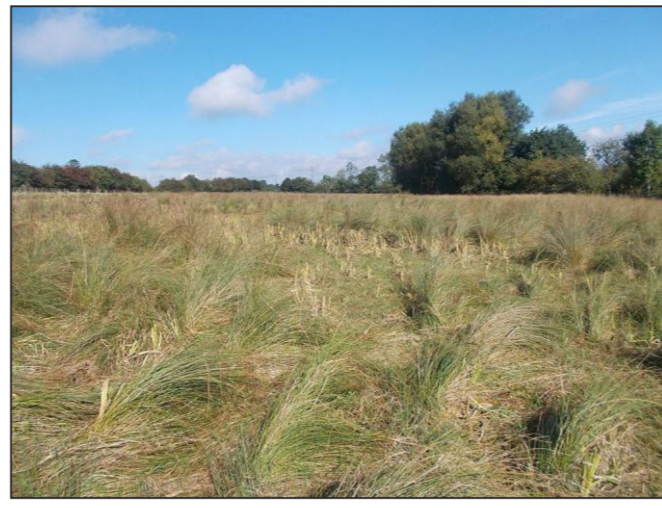
Inset 2 - Hydrophilic vegetation near the boggy ground to the north of the SSSI.

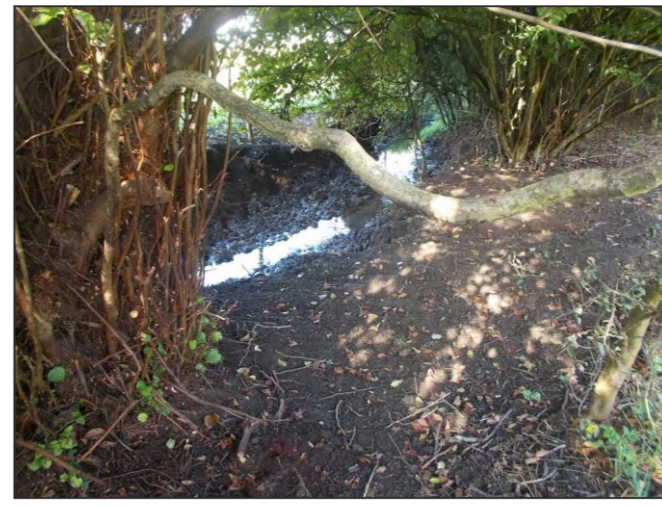
Inset 3 - Stream B at point B1. Very sluggish flow emanating from upstream wetland.

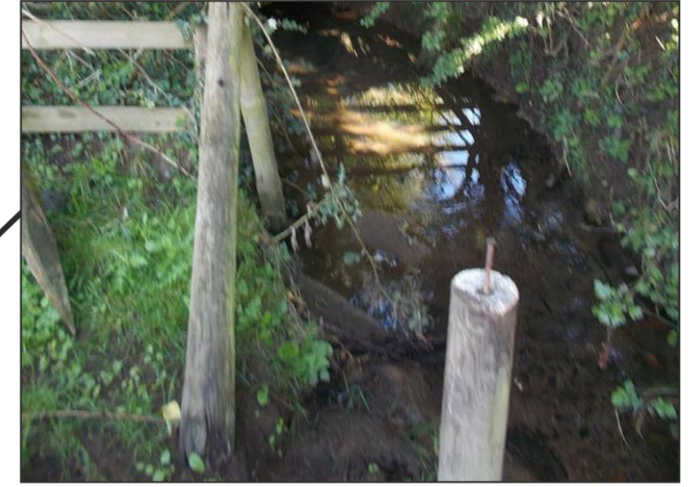
Inset 4 - Stream A at point A1.

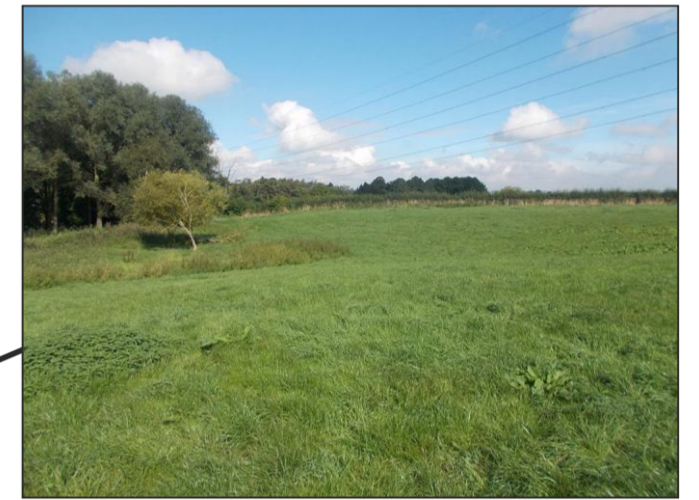
Inset 5 - Valley features immediately to the east of the SSSI. Groundwater issues may be occurring from this area during periods of high groundwater level.

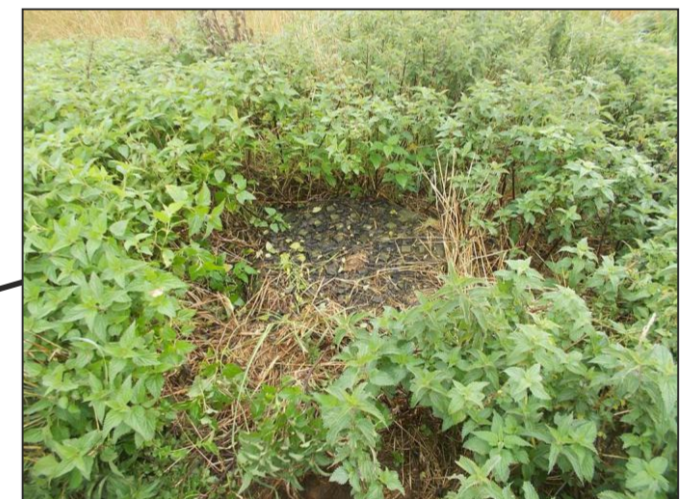
Inset 6 - Inspection manhole located along the decommissioned water collection infrastructure.

Item	Subject
	<p>outline of a water harvesting and supply system that was once used for PWS for Lutterworth.</p> <p>During the survey, some of the cast iron manhole covers we found outside the SSSI to the south, and others are visible on satellite image where there is arable, but nothing in the SSSI itself, (that area is overgrown wetland pasture).</p> <p>The current status of this system is being confirmed with LCC. If it remains, or part of it remains not properly decommissioned, then it is possibly having an effect on the hydrology of the SSSI.</p> <p>The SSSI condition is listed as Unfavourable / Recovering.</p> <p>Going forward as part of any planning application, a baseline monitoring plan would be prepared (see further work section in Item 7).</p>

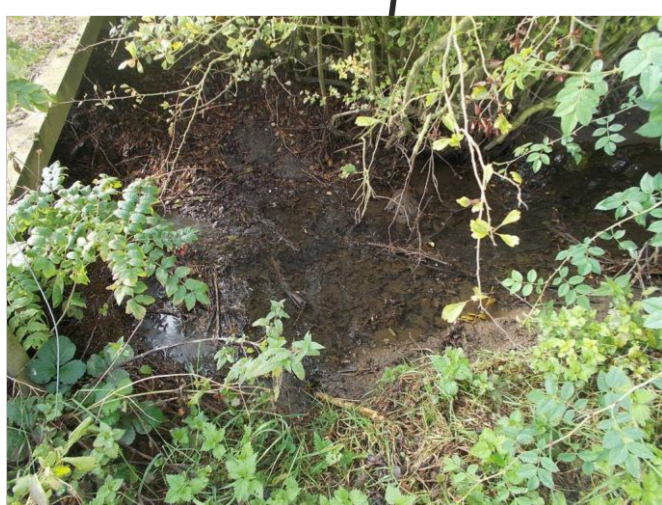
Inset 8 - Stream C immediately upgradient of point C1.

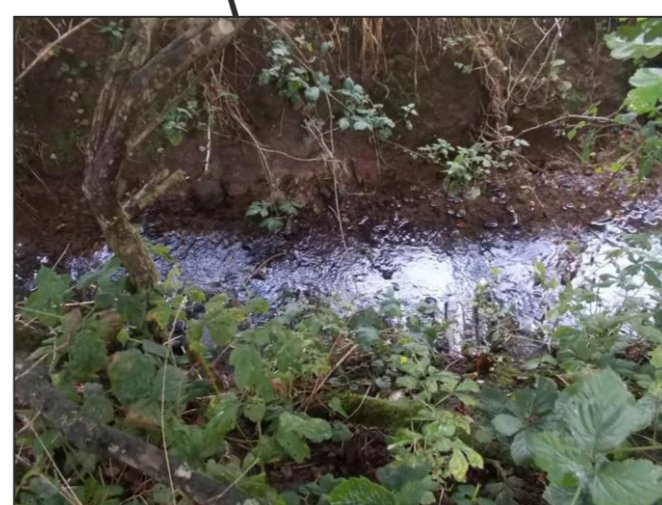
Inset 7 - Stream C immediately downgradient of point C2.
