**LAND AT GARTREE, MARKET
HARBOROUGH, LEICESTERSHIRE,
LE16**

**SUMMARY REPORT ON RESULTS OF
THE ARCHAEOLOGICAL EVALUATION**

Summary Report: Archaeological Evaluation on Land at HMP Gartree, Market Harborough, Leicestershire

Prepared by Robin Weaver, Pre-Construct Archaeology Limited

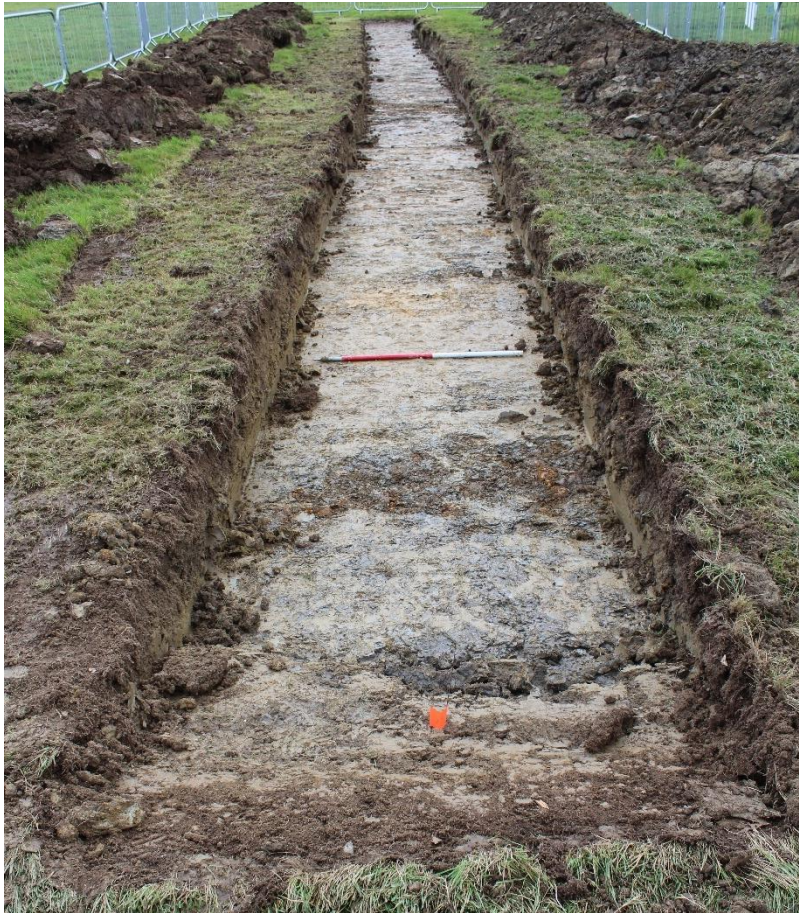
Plate 1: A typical 30m long evaluation trench, showing a sequence of orange geological clay, with grey-blue mottle, overlain by orange-brown clay subsoil, sealed by topsoil/turf. In the foreground is a band of manganese geology, picked out by the geophysical survey. A modern gravel land drain is seen in the centre ground (Trench 24 - 1m scale; looking southeast).

- 2.2 The natural substrate (**Period 1**) was encountered at varying depths across the site, and this was largely dependent on the effect of the airfield (**Period 6**). In the eastern part of the site (Trenches 1-9) and the central areas west of the brook (Trenches 36-39, Trench 52 and Trenches 41-49) the geological substrate was typically between 0.30m and 0.50m below the present ground level (Plate 1). This relatively wide margin is explained by the presence or absence of a clay subsoil.

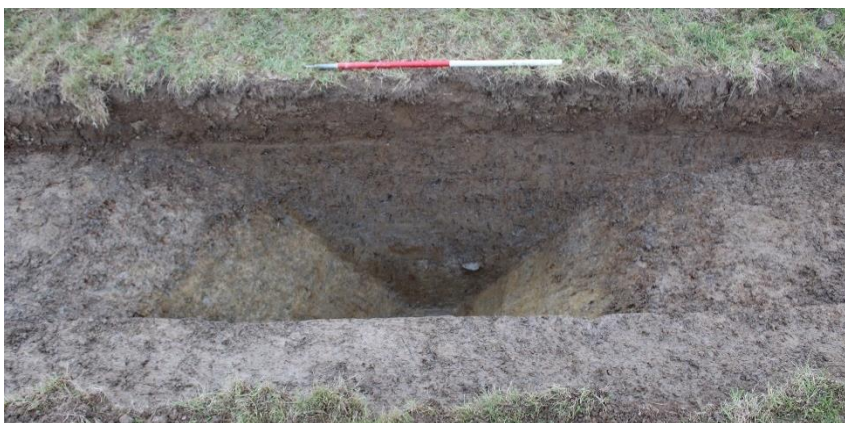
Plate 2: The Iron Age ditch in Trench 13 [1304], overlain by furrow [1305]. Note the manganese-rich purpleish geology of the upper sides of the ditch, which overlays the yellowish-orange clay geology further down in this shot.

- 2.5 Plate 2 demonstrates the basic archaeological sequence, with the geological manganese and clay substrates (**Period 1**) cut by Iron Age ditch [1304] (**Period 2**; see Figure 3), which itself was shallowly cut by a furrow (**Period 3**). The furrow was subsequently sealed by subsoil (**Period 4**), and in this case escaped the 20th century impacts on the site (**Periods 5-7**).

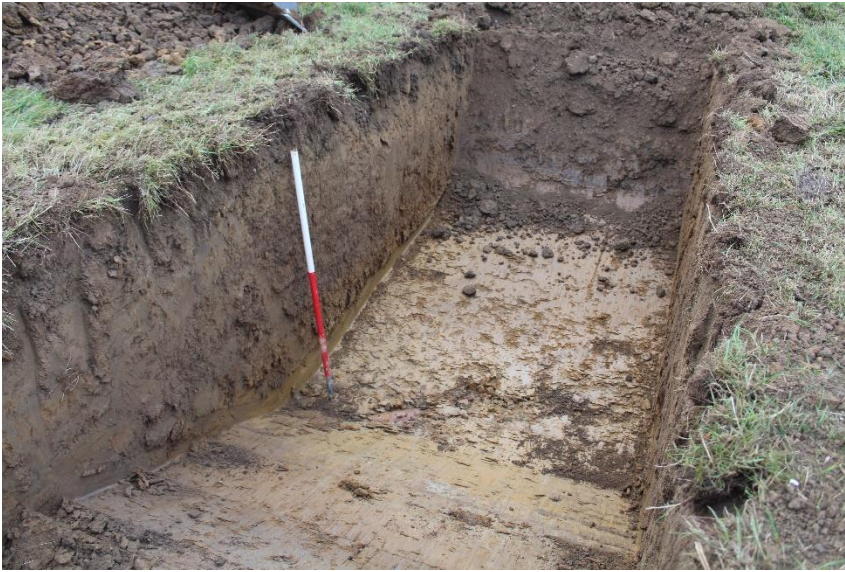
Plate 3: Excavation in Trench 32, where made ground (3203) and (3204) associated with the dispersal strip (see plate 6), directly overlays the geological substrate (3205) and an unbroken early 20th century land drain.

the geological substrate being truncated prior to the construction works. In Trench 32, for example, an unbroken early 20th century land drain was seen over 1m below the present ground level (Plate 3): significantly, no subsoils or buried previous topsoil/s were seen and it is therefore considered that the archaeological potential of locations where airfield activity was recorded is limited.

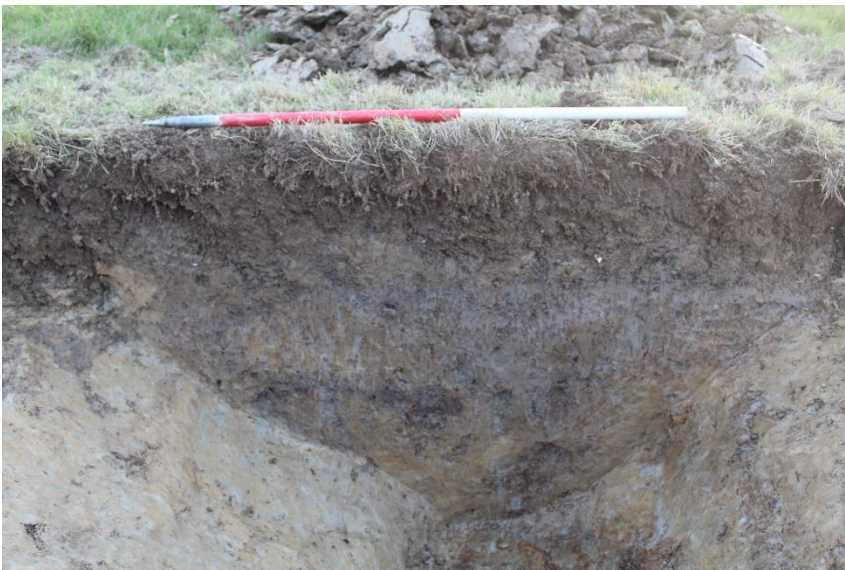
Plate 4: The iron slag-heavy ditch in Trench 14, [1407], which is part of the "L"-shaped feature seen in Trench 13 and 16 (1m scale; looking south).

- 3.1 Archaeological activity (**Period 3**) within the area of the site was situated entirely within the eastern portion of the site between the dispersal strip and runway No. 1 in Trenches 12 to 14 and 16 (Figures 2 & 3). Trenches 13, 14 and 16 recorded an “L”-shaped Iron Age dated ditch, which contained pottery including fragments of Iron Age Scored ware and iron smithing slag and an associated piece of furnace lining. The feature was oriented north northeast by south southwest in Trenches 13 and 14 and spurred to the west in Trench 16 where it terminated. Excavation showed that the ditches were up to 2m wide and between 0.50m (ditch [1605]) and 1.30m (ditch [1304]; Plate 2) deep, with narrow bases. This arrangement was predicted by the geophysics and a similar western spur and terminus may lie to the north of Trench 13, which fell within a badger exclusion zone (together with another possible feature to the north of Trench 12). The location of a curved possible feature to the west was also tested but proved to be geological, as did a suggested eastern spur targeted by Trench 56.

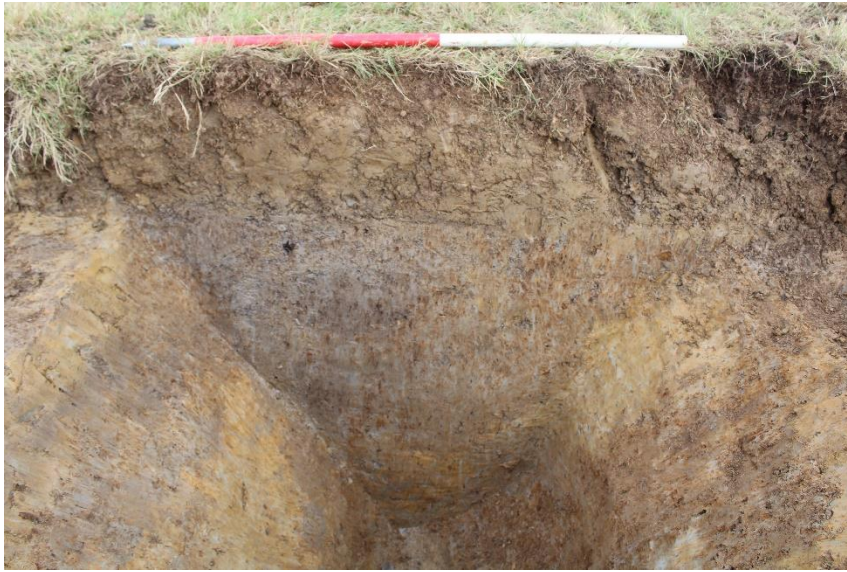
Plate 5: Iron Age enclosure ditch [1204] in Trench 12 (1m scale; looking east).

- 3.2 Trench 12 identified two predicted features, both near identical deep steep sided ditches of similar proportions to those of the “L”-shaped formation (Plate 5) and also dating to the Iron Age. With the geophysical survey in mind, these two potentially form a small subcircular enclosure, which is further suggested to link to a second such feature to the immediate east. In the general area of these two features, natural mudstone and / or manganese accumulations (to the south and east) and modern tarmac ‘crush’ modern land drains (to the east and north) define the limits of this archaeological area. To the immediate west and north is the airfield dispersal strip and made ground, discussed below.

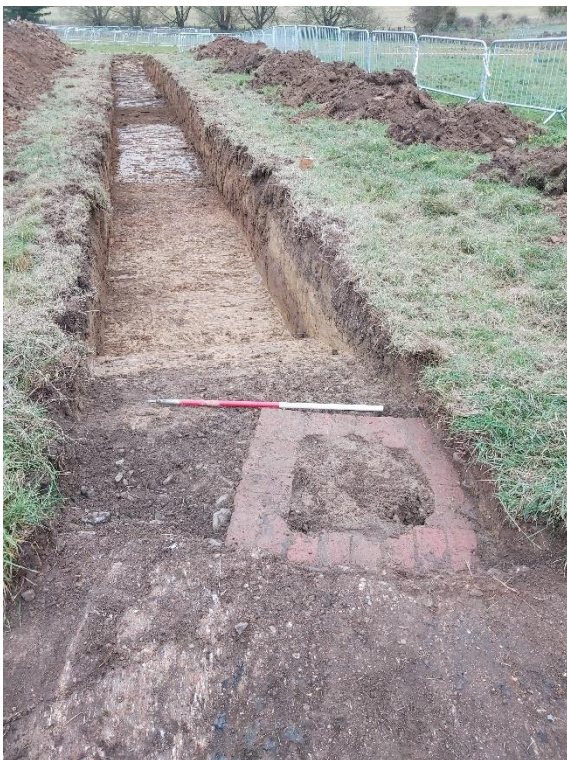
Plate 6: Trench 32, excavated against the concrete dispersal strip (3207), foreground, featuring a small brick structure {3206} and, beyond that, layers of made ground (3202), (3203) and (3204), over geology (3205) (1m scale).

- 4.1 The evaluation recorded only one small intact airfield structure (Trench 32; see Plate 6). The edge of the dispersal strip was uncovered and showed a small square brick structure, of unknown function but potentially a lighting or communications point, given the proximity to metal cables.

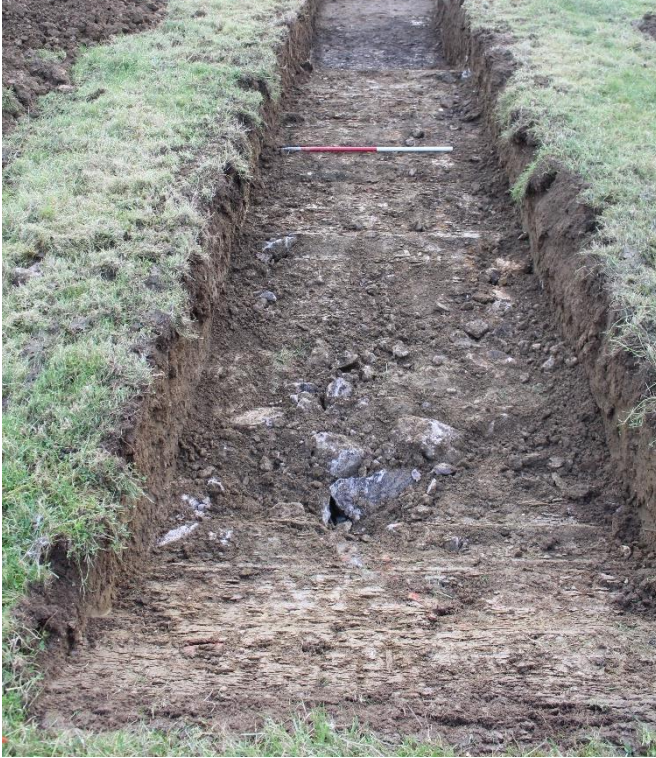
Plate 7: The northern part of Trench 35, which exposed truncation containing large broken blocks of concrete, amongst other debris. This area corresponds to an area of WW2 nissen-huts; see Figure 4 (1m scale; looking south).

- 4.3 It was noticeable that concrete was a feature of the two areas where buildings had previously been mapped, and in Trenches 35 and 51 large obstacles effectively limited the depth that the trenches could be taken (Plate 7).
