Gartree 2

Arboricultural Impact Assessment and Method Statement

Project Title: Gartree 2

Document Number: 661277-0000-TYL-GTX0000-XX-RP-X-0002

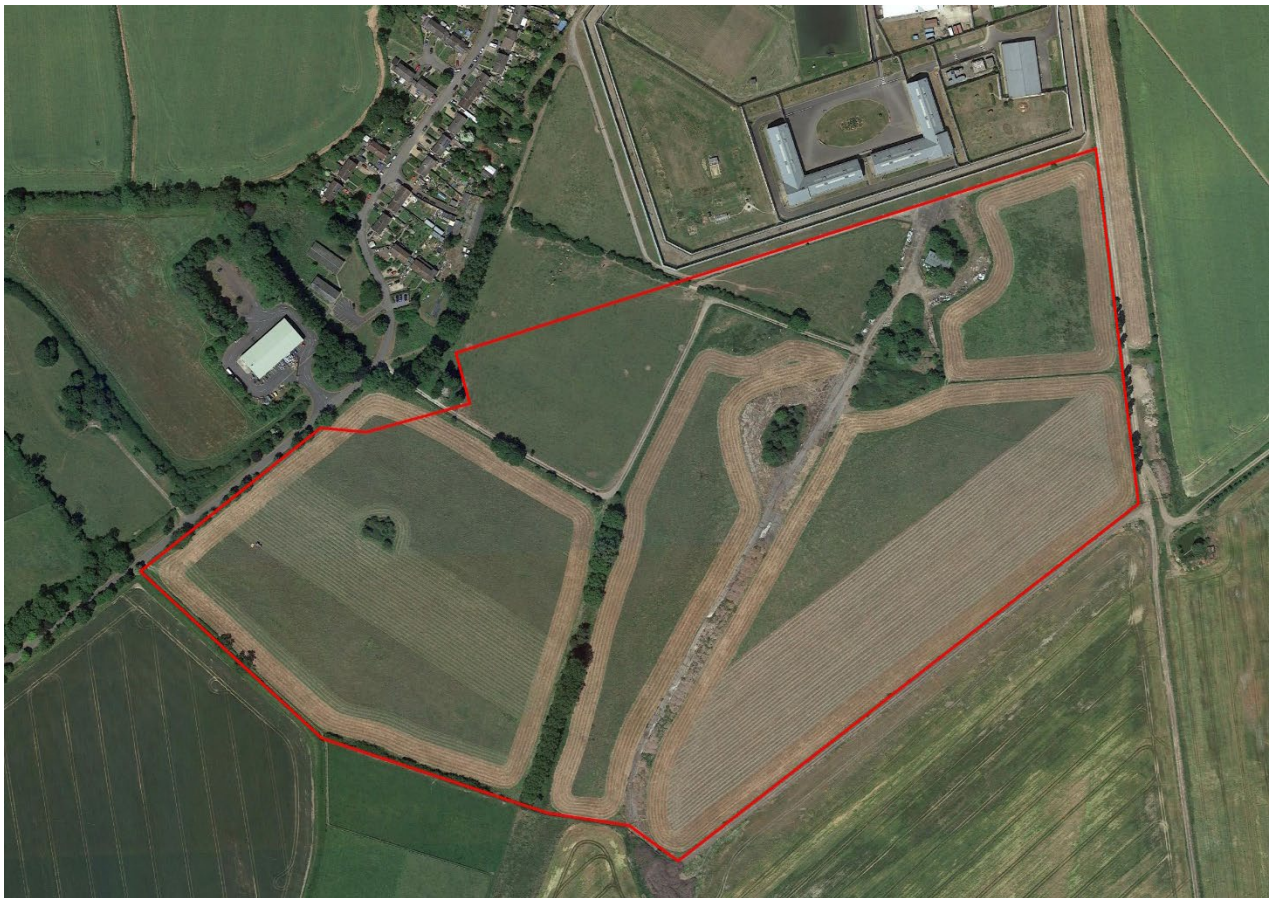
Figure 1. Indicative Survey Boundary (Imagery © Google Maps, 2021).

- 2.1 The site is centred on national grid reference SP 70640 88741 and the survey extended across the main prison area as shown at Figure 1 below and on the **Tree Constraints Plan (TCP) (See Plan 1)**. The application red line boundary includes additional land to the north and west of the area surveyed known as the northern and western area as shown at Appendix 1. These areas have not been subject to a tree survey as the trees will not be affected by the development as it includes new planting and habitat creation only. The site is located south of the HMP Gartree development and comprises a series of agricultural fields under arable use.

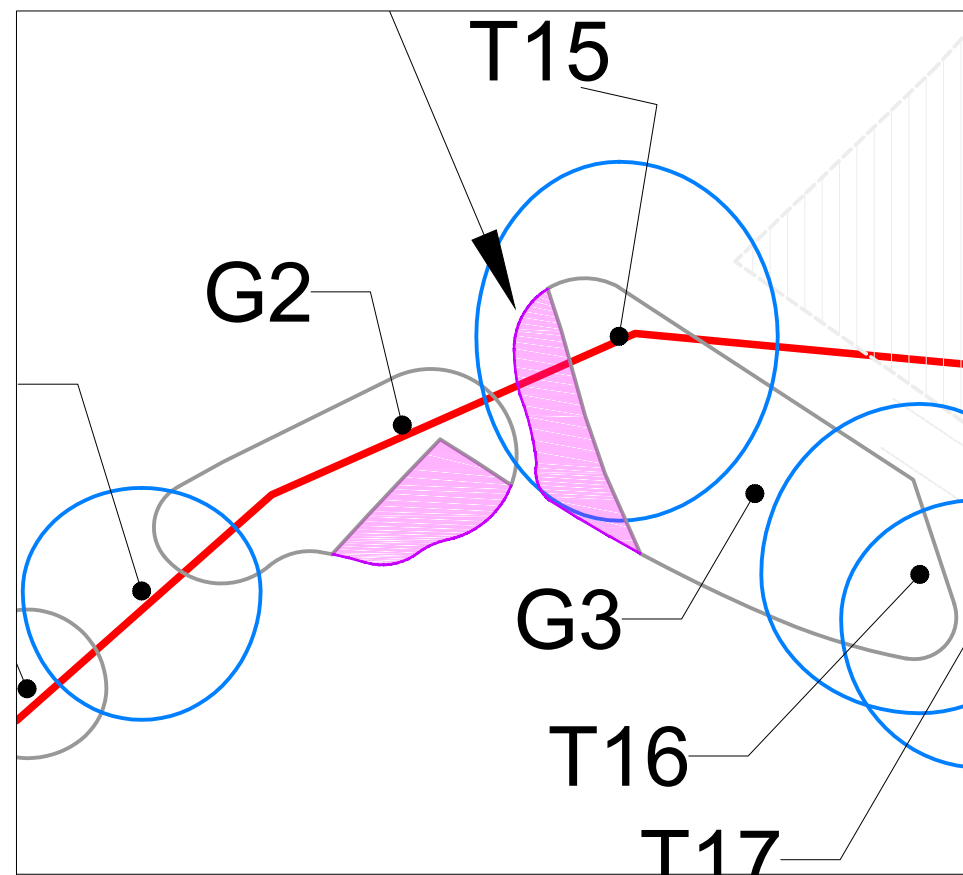
Extract from Tree Retention and Removal Plan (13500/P02) showing all areas of tree pruning

1. Two groups require cutting back either by pruning or selective removals as required. These areas are shown as with a **pink hatch** on the Tree Retention Removal Plan ref:13500_P02

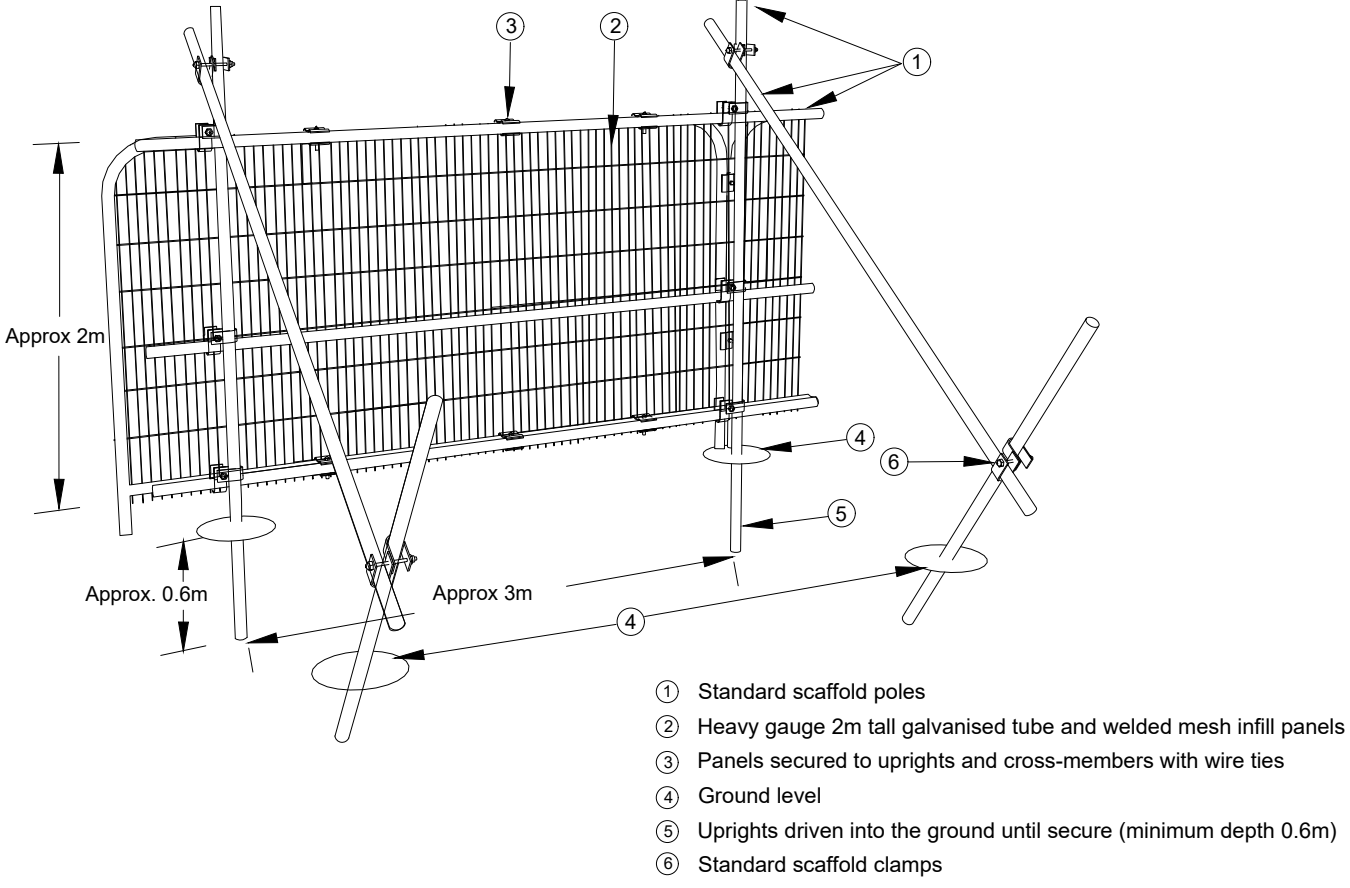
Figure A: Default specification for protective barrier

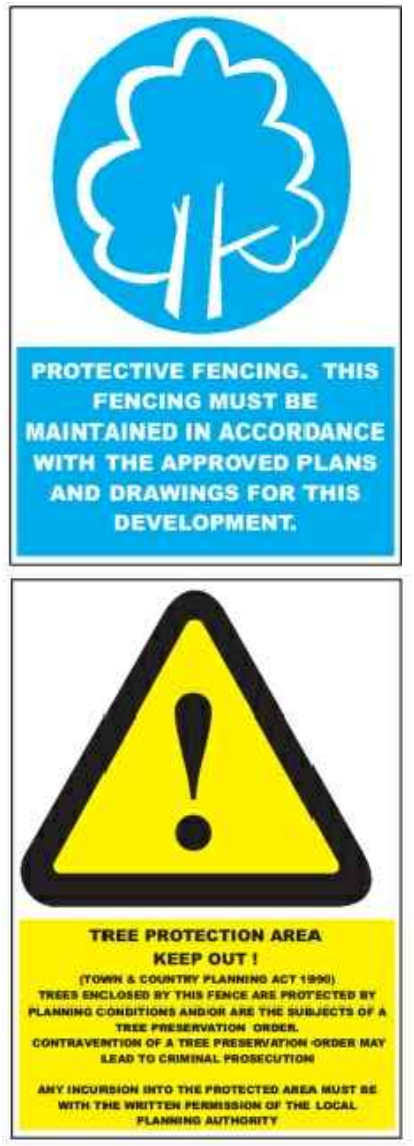
Figure B: Signage Example

8. All-weather notices will be attached to the barriers with words such as 'Construction Exclusion Zone - No Access' (see **Figure B and Appendix 4** for a full A4 size).

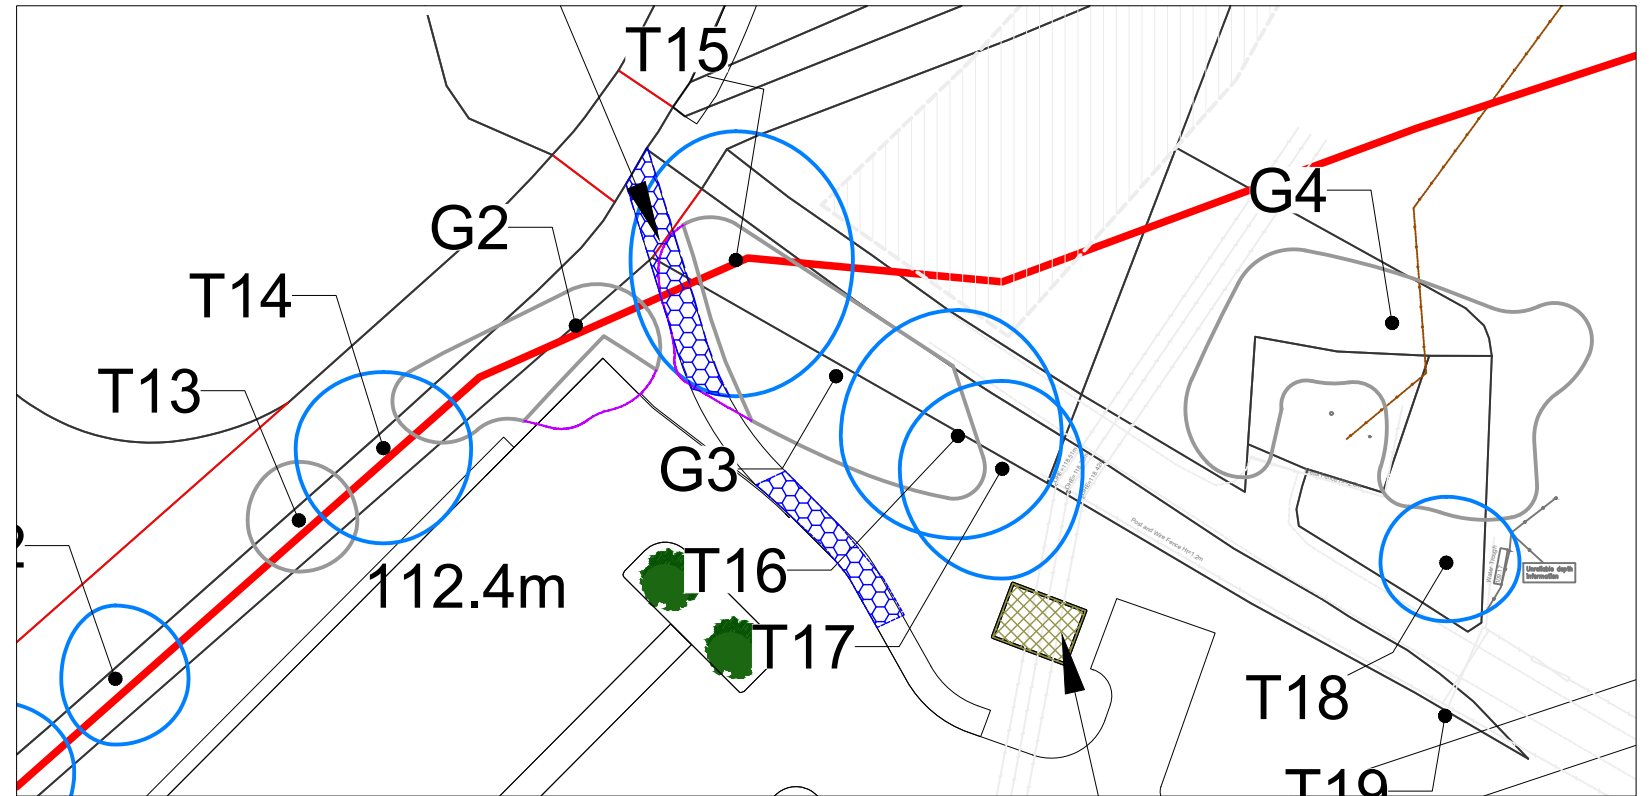
- Exposed roots will be covered with top soil or a hessian sack to avoid root desiccation;
 - Exposed roots to be retained as part of the construction will be supported by sharp sand; and

- Due to the highly alkaline leachate produced during the curing of wet concrete, concrete should not be poured within the RPA unless an impermeable liner has been installed. Holes must therefore be sheathed to reduce the risk of contamination where concrete is to be implemented.

Figure A: Identifying typical methodology/arrangement for manual excavation works within RPA
