Gartree 2, Market Harborough, Leicestershire

S3 Suitable for Review & Comment
Archaeological Watching Brief

Report No. Y529/21

**Archaeological Watching Brief
Official – Sensitive**

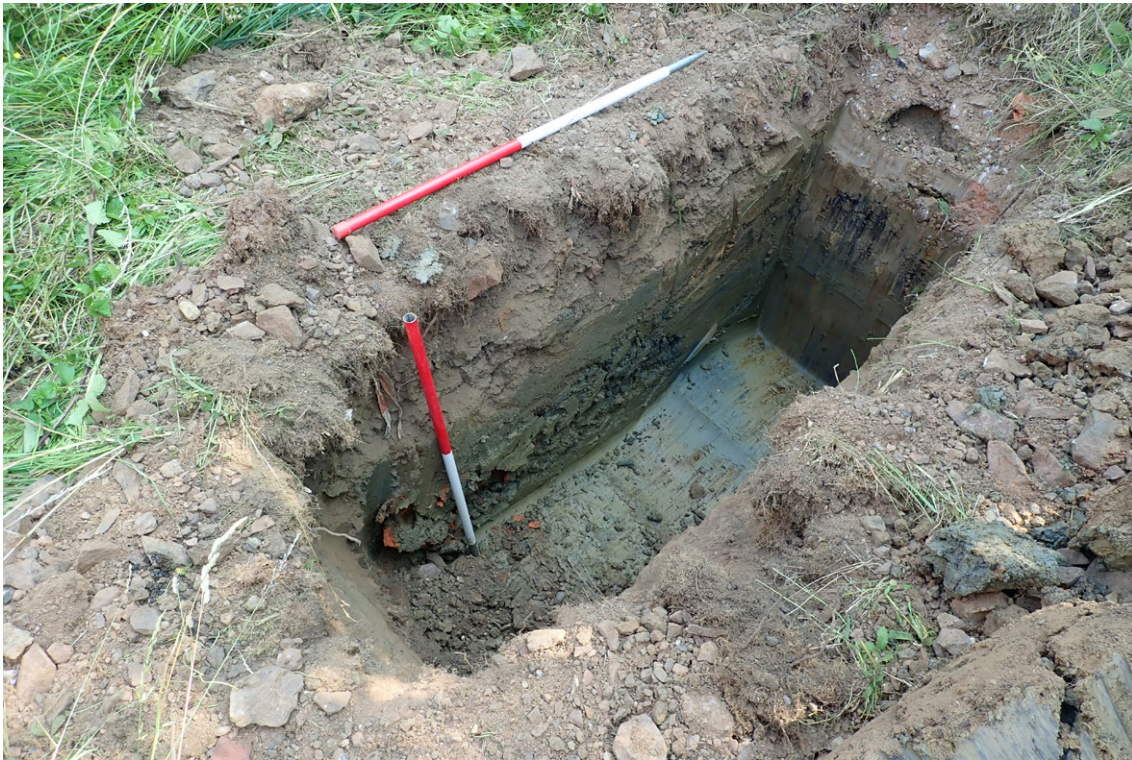
Fig. 3.1: South facing section of Trial Pit 102

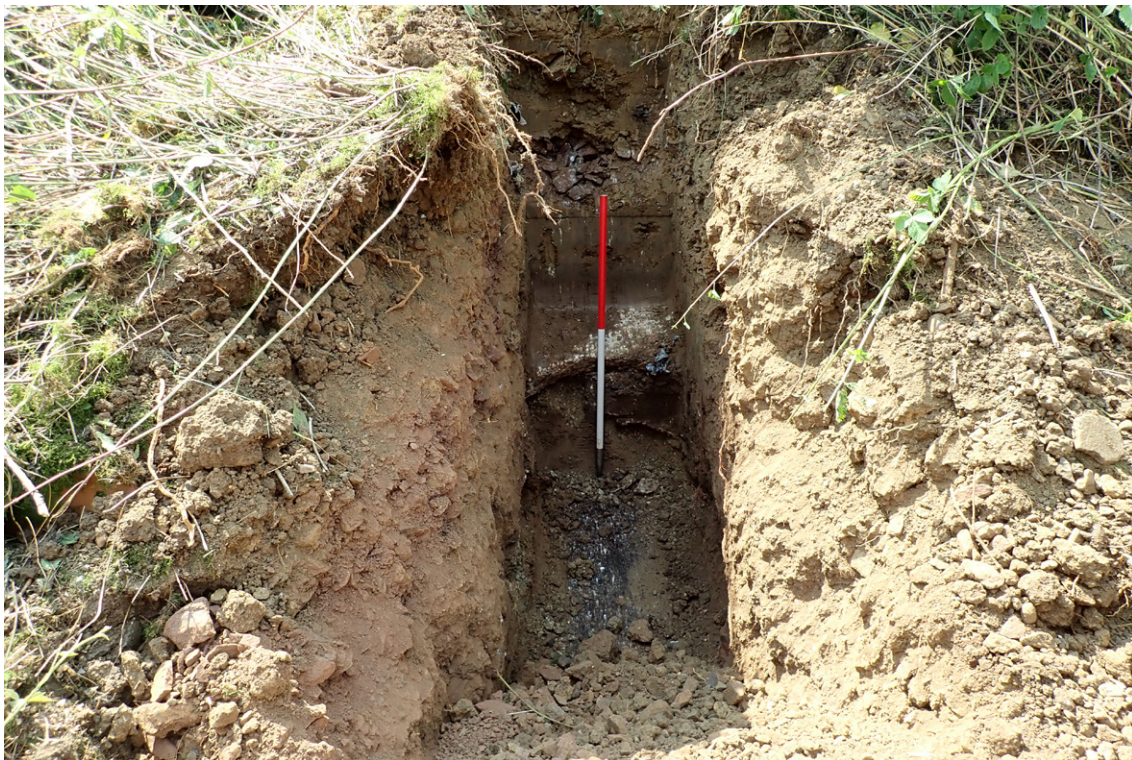
103	<p>The 0.7 by 2.2m trial pit was orientated north to south into the western slope of a large mound covered by vegetation. Excavated to a total depth of 1.70m (Fig. 3.2).</p> <p>Topsoil was observed at a maximum depth of 0.15m and consisted of a dark grey-brown sandy silt overlying a deposit of made-ground at a thickness of 1.55m comprising a mid-yellow-brown sandy silt with frequent rubble brick and concrete overlying the former runway.</p> <p>No archaeological features were identified.</p>
104	<p>The 0.7 by 2.2m trial pit was orientated SE to NW into the north-western slope of a large mound covered by vegetation. Excavated to a total depth of 2.50m.</p> <p>Topsoil was observed at a maximum depth of 0.10m and consisted of a mid-grey-brown sandy silt overlying a deposit of made-ground at a thickness of 2.40m comprising a mid-yellow-brown sandy silt with frequent rubble brick, concrete and possible steel rebar overlying the former runway.</p> <p>No archaeological features were identified.</p>

Fig. 3.2: North facing section of Trial Pit 103

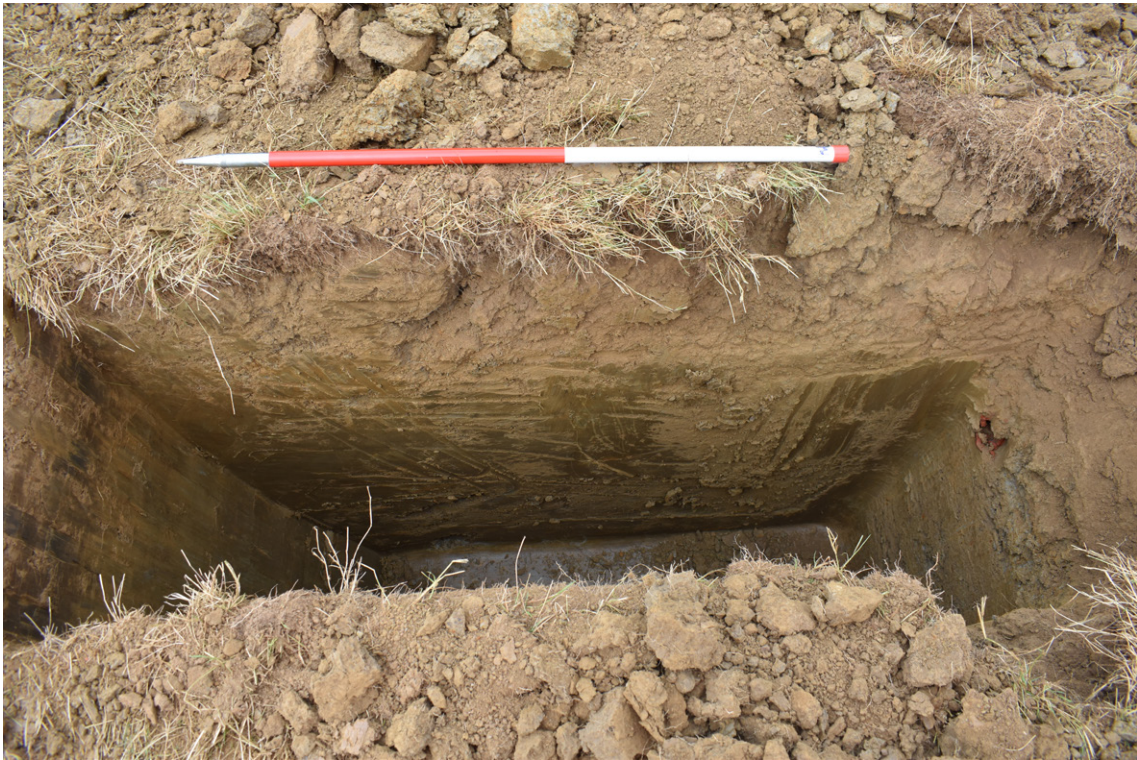
<p>overlying the natural substrate comprised of a dark mottled grey and orange clay.</p> <p>No archaeological features were identified.</p>
104A/104B	<p>SA104A was backfilled following groundwater seepage rendering it inoperable. 104B was then excavated adjacent reaching a level just above the water table. Measuring 2.20m by 0.60m it was excavated NE to SW on a flat meadow to a depth of 2.30m (Fig. 3.3).</p> <p>Topsoil was observed to a maximum depth of 0.40m and consisted of a mid-orange-brown clayey silt overlying the natural substrate comprised of a dark mottled orange and grey clay.</p> <p>The observable stratigraphy within SA104B was identical to SA104A however this was only excavated to a total depth of 2.0m.</p> <p>No archaeological features were identified.</p>

Fig. 3.3: North-west facing section of Soakaway 104B

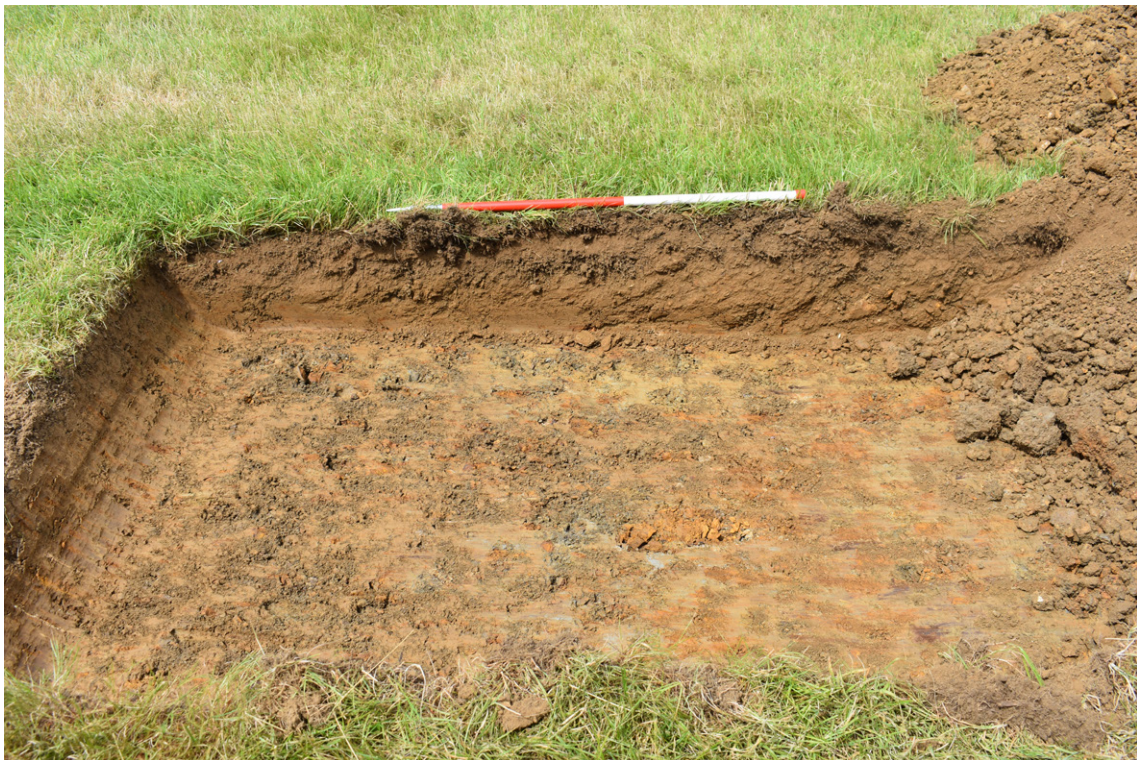
A further 17 small pits were excavated in order to undertake soil load bearing tests to obtain a ‘California Bearing Ratio’ (CBR). All CBR pits were excavated in areas of grassland around the site to the interface of the natural geology which varied in depth from between 0.19m to 0.60m (Figs. 2 and 3.4). There was no clear definition between the topsoil and subsoil layers, rather both can be characterised as a mid-light yellowish brown clayey silt with a diffuse interface distinguishable only by their varying degrees of compaction. In all instances the natural substrate comprised a mid-orange mottled grey clay and no archaeological features were identified.

Fig. 3.4: North facing shot of CBR Test Pit 108
