**Foxtton Primary School, Gallow Field Road,
Market Harborough, Leicestershire**

School Route Safety Assessment

TMS reference no: 1790

Date: 2nd September 2022

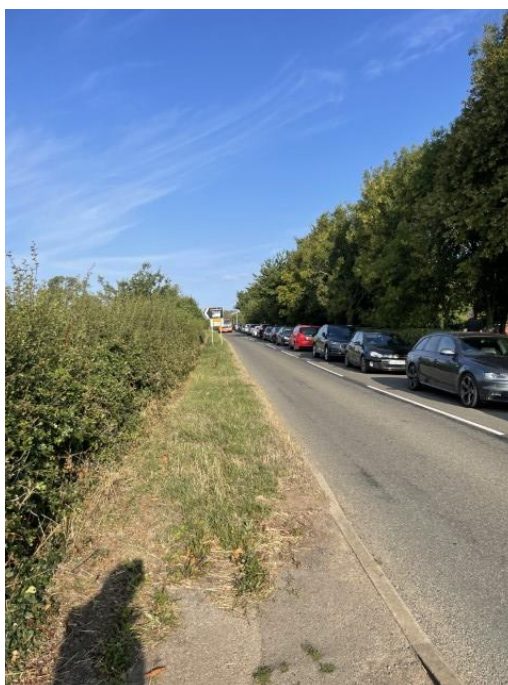
The majority of parents dropping off their children at the school parked their vehicles on the north side of Gallow Field Road either side of the main school entrance with some contravening the school zig-zag markings and others parking across white painted H-bar markings at the east side dropped crossing point. This created a continuous block of parked vehicles effectively narrowing Gallow Fields Road to a single lane carriageway for over a 100metre length. Through traffic therefore had to give and take for opposing traffic flows.

Parked cars outside school narrowing carriageway to one lane

With the potential increased traffic flow as a result of the new prison development, the issue from the narrowed single lane carriageway from parked cars for the school drop off / pick up could be further exacerbated. Drivers might become impatient and take more risks to manoeuvre around the parked vehicles increasing the risk of head-on collisions with oncoming traffic. Traffic giving way might also queue further back into the junction with Foxton Road increasing the risk of shunt collisions, where drivers turning might not be expecting stationary traffic.

The parking should be reviewed to reduce the number of vehicles parking on Gallow Field Road outside the school, such as providing parking within the school grounds with a pickup / drop off area or formalised off carriageway parking bays installed.

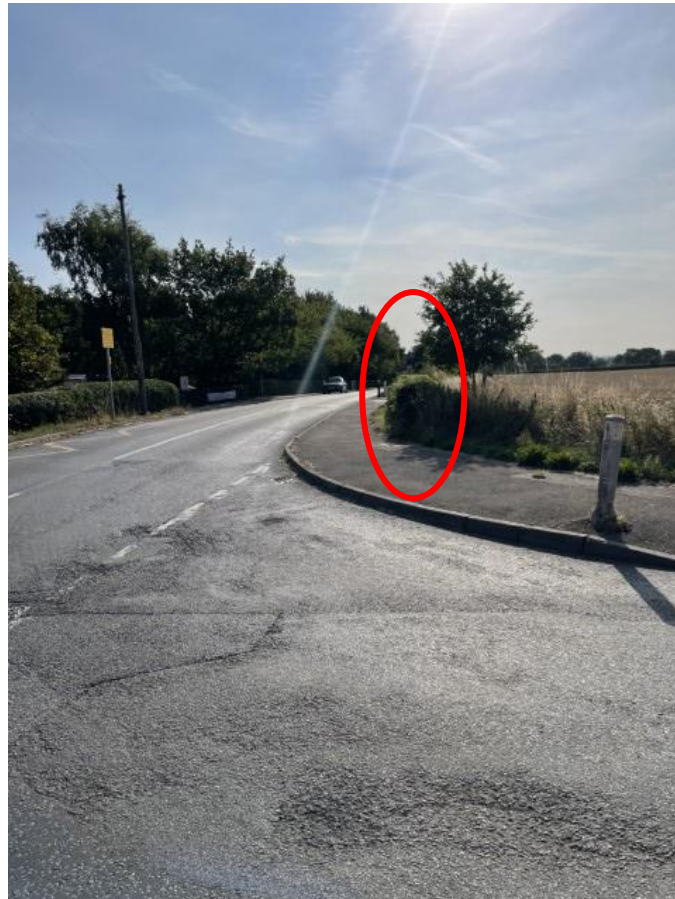
Forward visibility was good in both directions outside of the school along Gallow Field Road but did eventually become obscured by the parked cars from parents dropping off their children. At the junction with Foxton Road visibility was restricted to the right by a boundary hedgerow.

Visibility splay restricted to the right at Foxton Road

For traffic approaching the school from the Foxton Road approach, the visibility splay was obscured to the right due to a boundary hedgerow. Drivers might not see approaching vehicles and pull out increasing the risk of collisions occurring. The problem could also be exacerbated from the increased traffic flows from the proposed prison development.

The hedgerow should be cut back ensuring there is a clear visibility splay to the right.

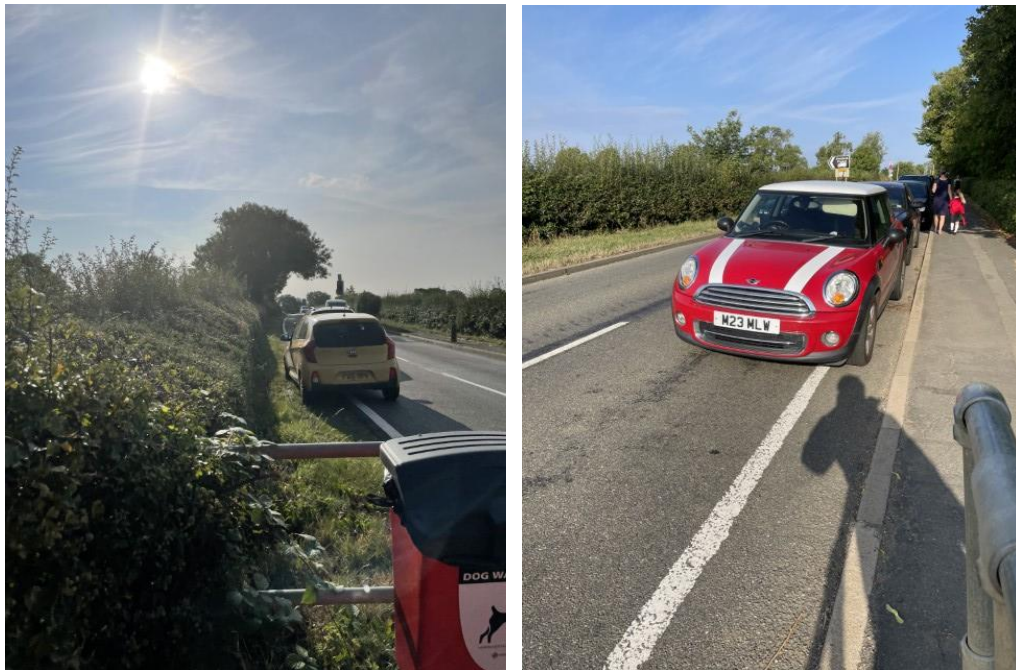
Pedestrians crossing from the footway on the north side (school side) of Gallow Field Road had a restricted visibility splay to both the right and the left due to parents' parked cars.

Restricted visibility at crossing point (both directions)

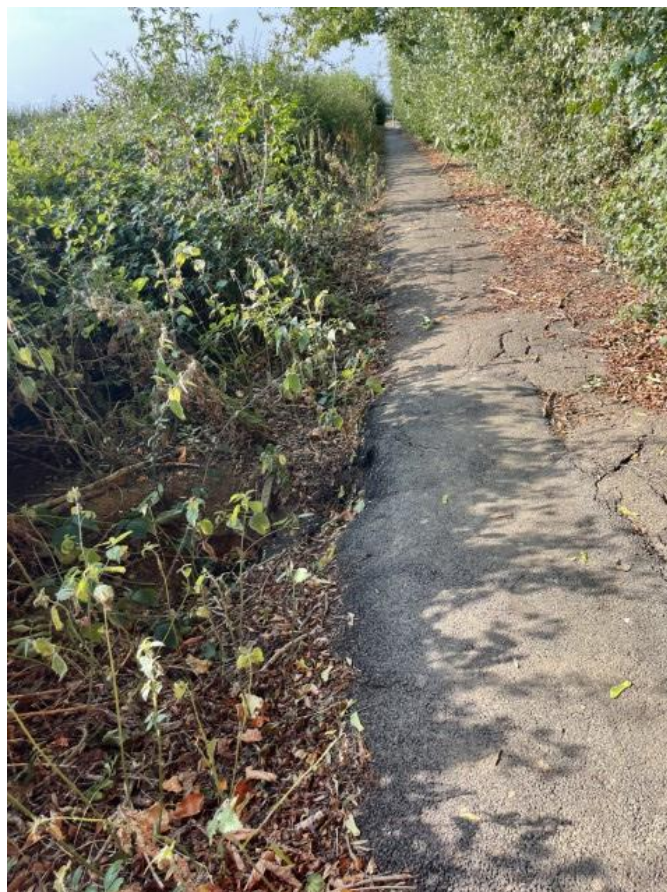
From the proposals to reduce parking from outside the school and provide alternative parking on Swingbridge Street, footpath (A22) linking this to the school is not a suitable route for pedestrians to use, (even if this is widened). The surface is uneven with a number of potential trip hazards from badger holes and is of a steep gradient presenting a fall hazard for mobility impaired pedestrians. The alternative parking area is also a long distance away from the school with no pedestrian facilities. This unlit footpath is unlikely to be a desirable route for the school drop off / pick up, especially in the winter months when this could be in darkness beyond 4pm.

Footpath with steep gradient and drop offs at the edges

Alternative parking arrangements should be installed closer to the school. If this is not possible then major changes to the footpath would be required, with a reduction in gradient, a route over the stream, such as a culvert and footpath lighting for the winter months to make the route as desirable and safe as possible.

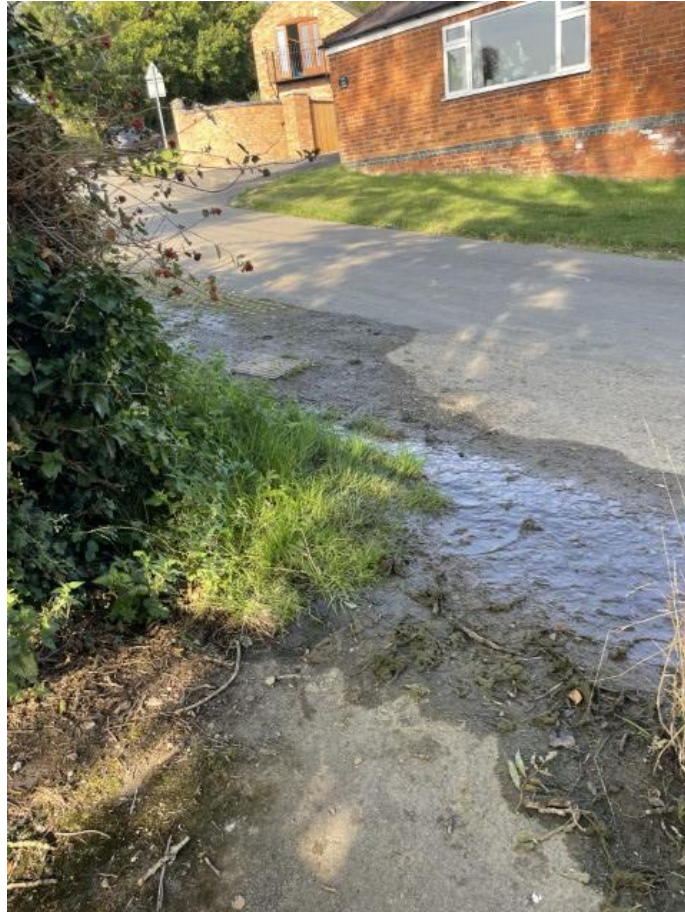
Furthermore, at the footpath entrance on Swingbridge Street there is a stream which runs down the carriageway. This could present a slip hazard to pedestrians which could potentially ice over in the winter months.

Stream at entrance to footpath

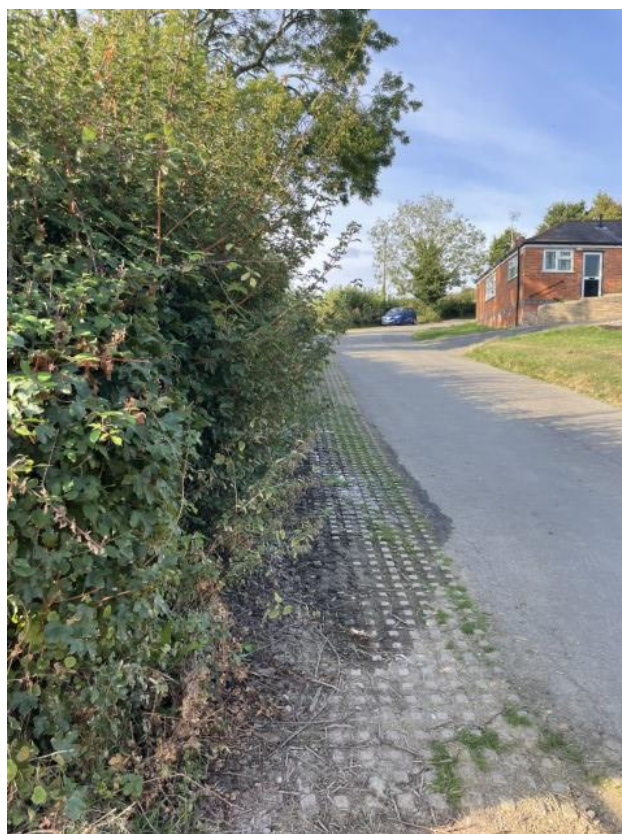
The parking bays on Swingbridge Street currently consist of a grasscrete surface and are very narrow. Vehicles parked here might overhang the narrow carriageway at this location, which is only approximately 4m wide. There is also a 90degree bend just south of this location restricting forward visibility. This could increase the risk of collisions with parked vehicles and collisions with pedestrians entering / exiting their vehicles who will be in the carriageway as there are no footways present.

As per problem 4.2, alternative parking should be installed closer to the school and with greater carriageway width available. If this is not possible then the existing parking bays should be widened with a footway link and pedestrian facilities to the footpath.

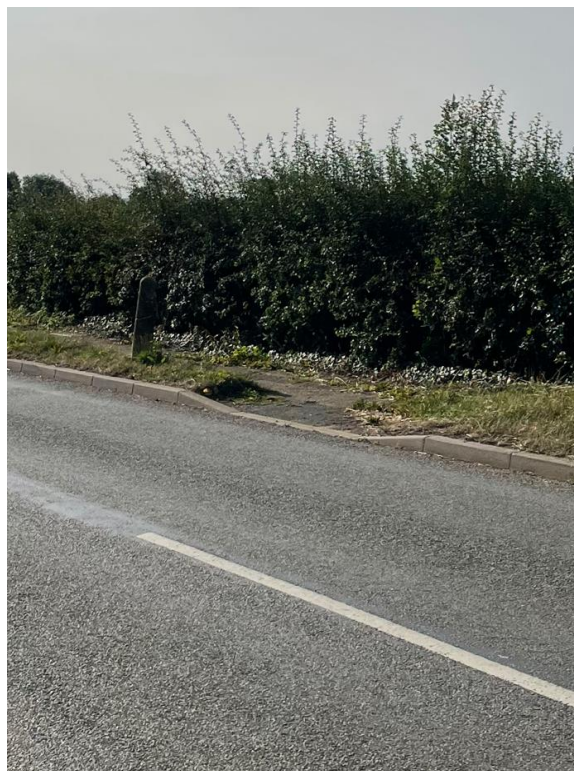
The dropped crossing points in the vicinity of the school were in a poor condition with high upstands, no tactile paving for visually impaired pedestrians and were not protected by any parking restrictions. This could increase the risk of pedestrians tripping and falling on high upstand kerbs and increase the risk of having to walk between parked cars. Visually impaired pedestrians might also cross at less appropriate locations with the increased risk of being struck by oncoming vehicles. This issue could also be worsened by the potential increased traffic flows as a result of the prison, where uncontrolled crossings might not be sufficient for the traffic volumes and pedestrian footfall.

Example of crossing point

The dropped crossing points should be improved ensuring they are flush or with a maximum upstand of 6mm and tactile paving installed for visually impaired pedestrians. The crossing points should be reviewed, upgraded and include suitable parking restrictions appropriate for the projected footfalls and traffic flows.

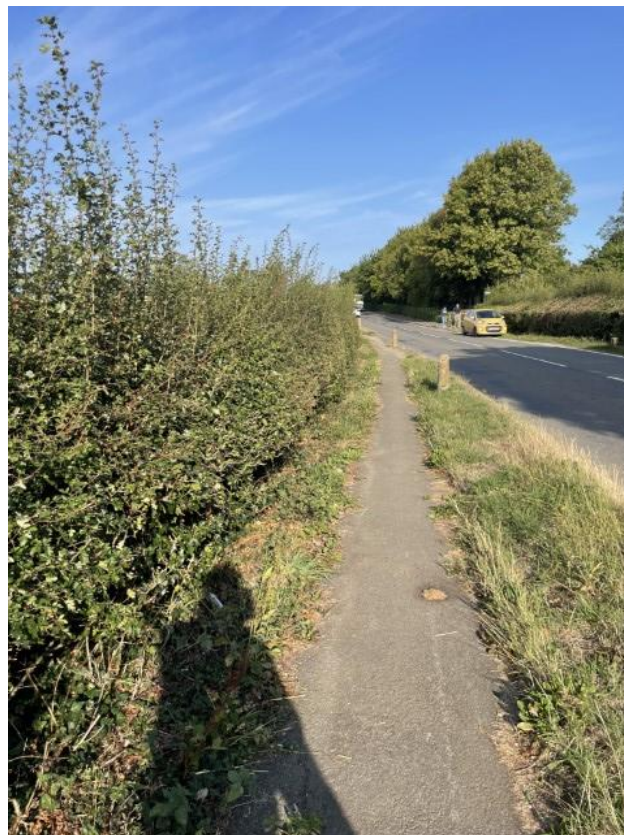
The footway heading east for pedestrians accessing the school from Gartree Village was overgrown, with the footway width narrowed with excess grass verge area. Pedestrians could slip and fall on the grass verge area especially during inclement weather.

Vegetation from the footpath should be removed, ensuring a clear route for pedestrians to access the school from Gartree Village.

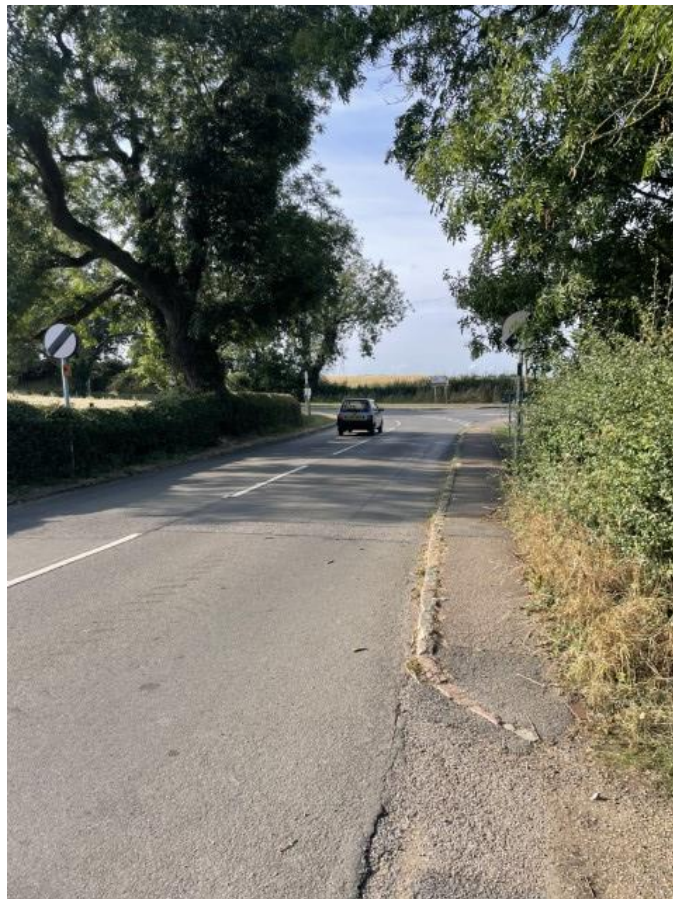
Although the village of Foxton is 30mph, this does not extend to the school section, which although has some advisory 20mph zone signs the limit is not legally enforceable. With the high pedestrian footfall at peak school times and the potential increase of traffic from the prison development, this could increase the risk of speed related collisions occurring outside the school, especially as motorists will be encouraged to speed up when they see the national speed limit signs as they leave the village.

National speed limit gateway on approach to school

The 30mph limit of Foxton village should be extended to include the school as per DFT circular 1/2013 'Setting local speed limits'

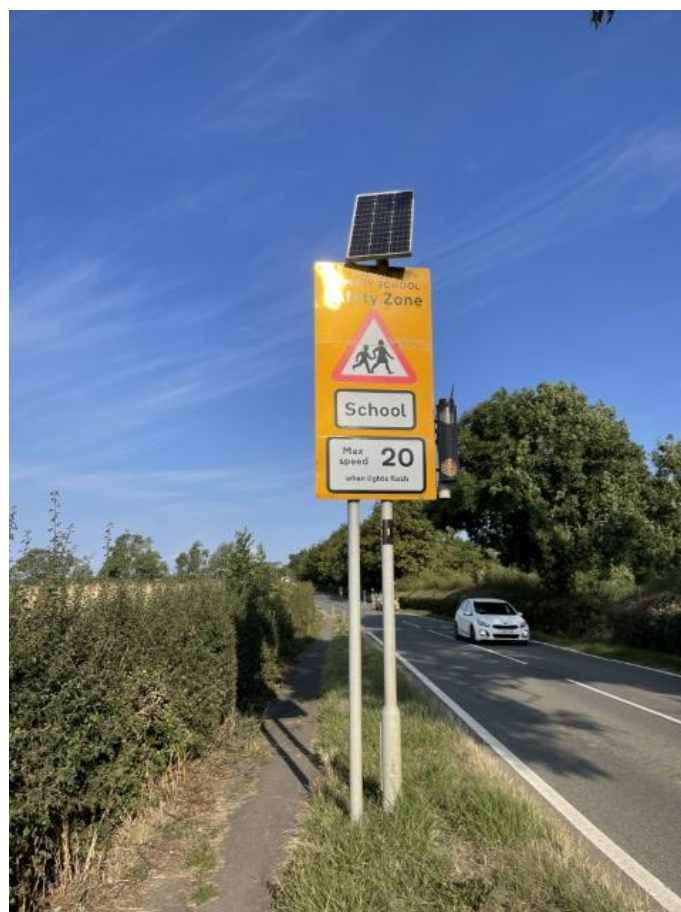
Some of the 20mph Zone sign information is of a small text 'x-height', where drivers might not view this and only the east approach flashing amber warning lights were active / present. Drivers might not be as aware of the 20mph recommended limit ahead and not slow down sufficiently, increasing the risk of speed related collisions outside of the school.

Small text size on signs

The text 'x' height on the 20mph zone signs should be increased suitable for the speed limit of the road. Flashing amber warning lights should be installed on the Foxton Road approach. The flashing amber warning light on the west approach sign should be repaired.

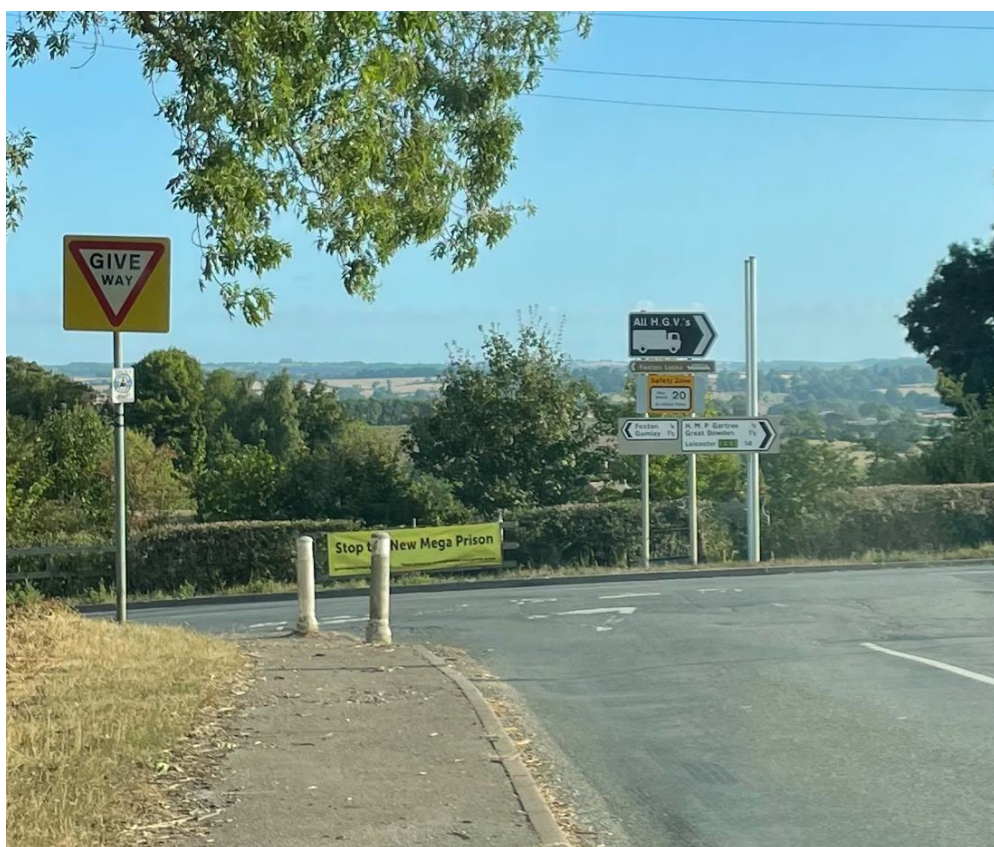
There is excess sign clutter for drivers approaching Gallow Field Road from the Foxton Road junction. They might be distracted from trying to read the extensive information (which is also of small text size) and this could increase the risk of junction collisions such as pulling out into oncoming traffic.

The sign information should be re-designed and consolidated with sufficient text 'x' height suitable for the speed limit of the road.

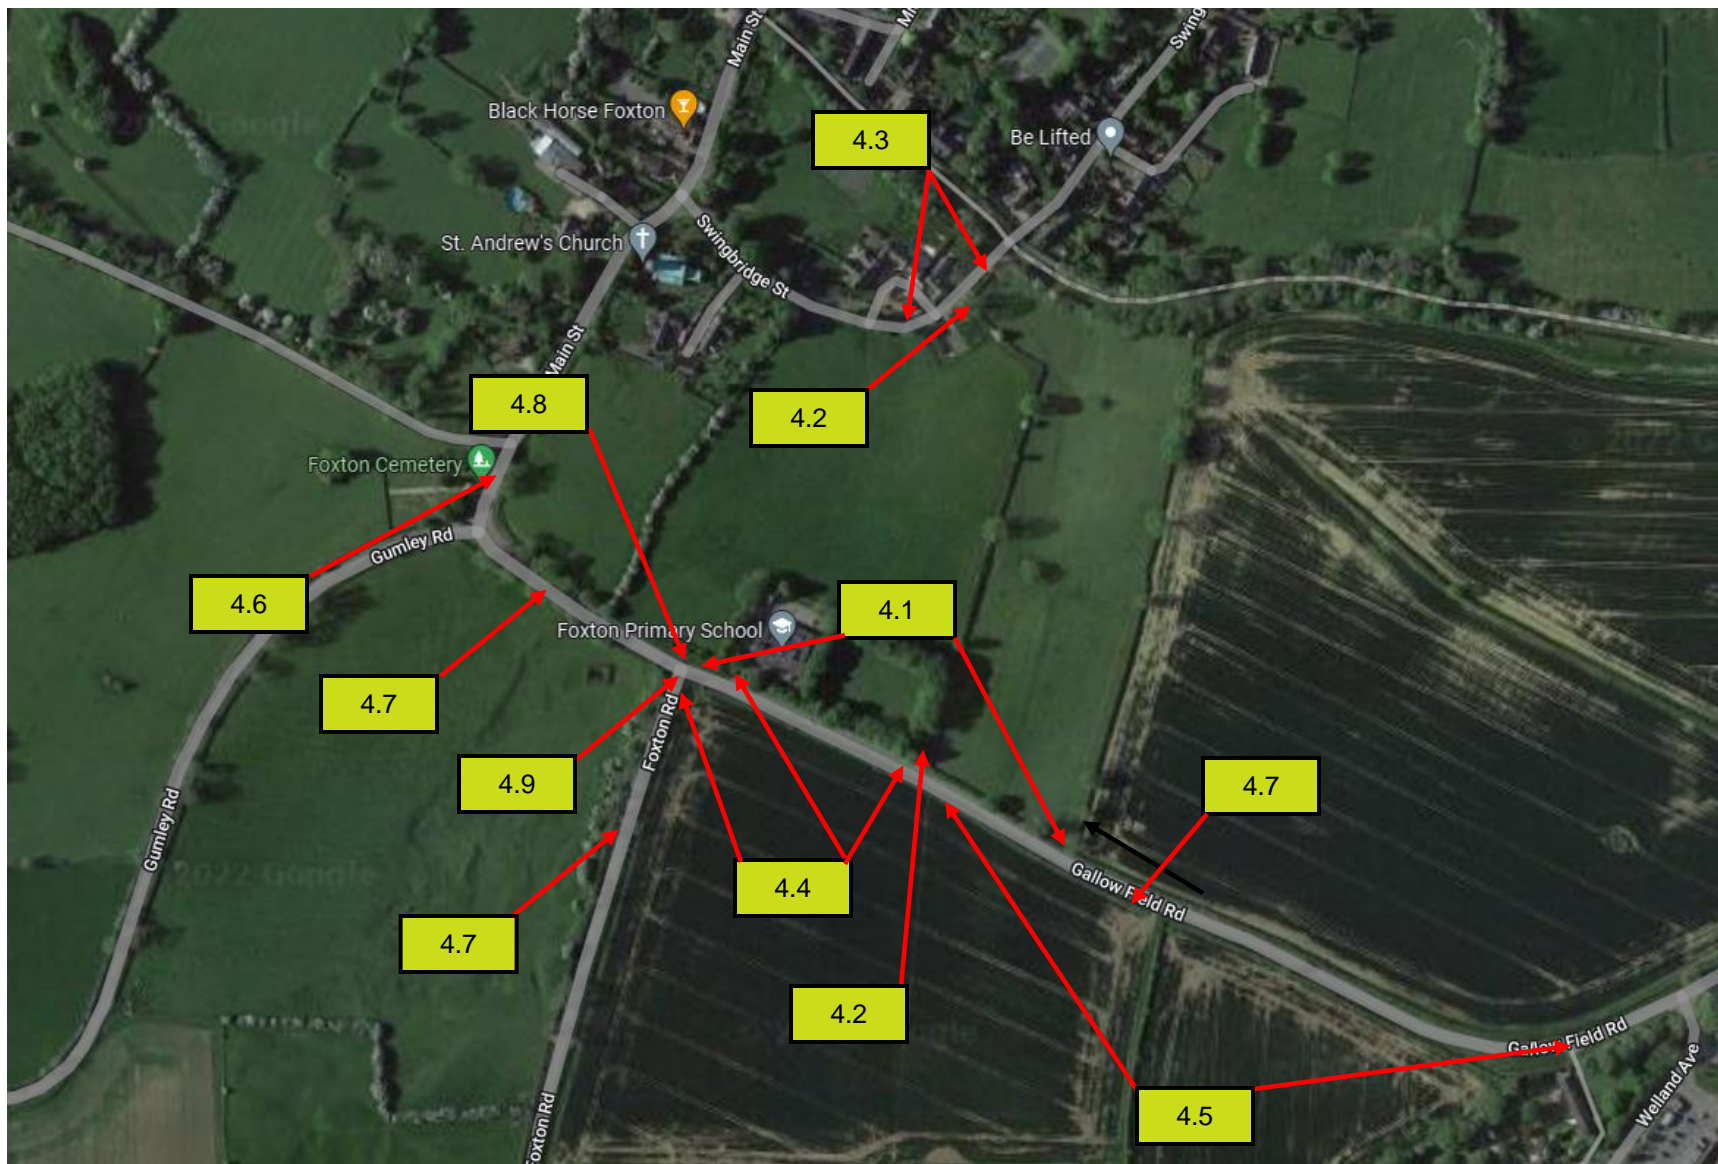
Please refer to the following page for a plan illustrating the locations of the problems identified as part of this assessment (location numbers refer to paragraph numbers in the report).
