# **Flood Investigation Report**

Storm Henk

2<sup>nd</sup> January 2024

**Broughton Astley**

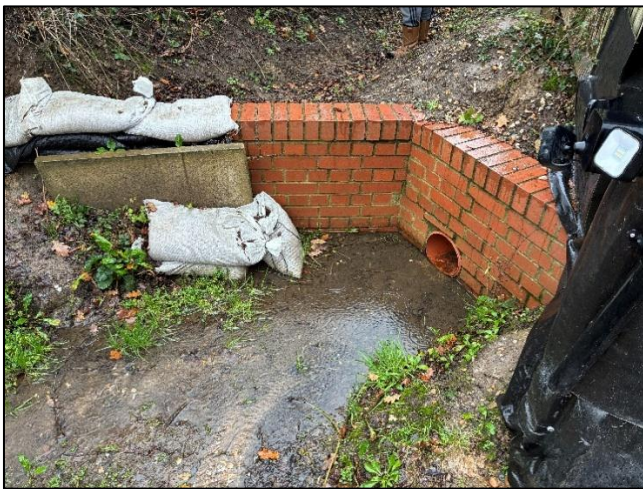
Here, surface water enters a 225mm diameter culvert pipe (Photograph 4-1), which flows under the rear garden of 20 Fretter Close and then under neighbouring rear gardens. During high flows, the pipe capacity is exceeded (Photograph 4-2) and surface water overtops into a higher-level ditch between 29 Dunton Road and 20 Fretter Close. The higher-level ditch enters a 225mm culvert pipe (Photograph 4-3), which eventually enters a manhole and turns right (Photograph 4-4) under the Fretter Close development and passes across the front of several properties along Fretter Close.

**Photograph 4-1: 225mm dia culvert inlet during low flow conditions – December 2025**

The capacity of the private 225mm pipe to the rear of 20 Fretter Close and 29 Dunton Road was quickly exceeded. The arrangements described above (Section 4.1.2 'Drainage Ditches to the West of Fretter Close') cause water to enter a higher-level overflow ditch and then into a second 225mm pipe between the two properties (as illustrated in Figure 4-4). Photographic and video evidence submitted as part of the investigation, shows clearly that the second 225mm pipe became overwhelmed.
